SERVICE BULLETIN

APPLICABILITY: 2019-24MY Ascent
2020-24MY Outback & Legacy 2.4L

NUMBER: 09-130-25R

SUBJECT: Exhaust Manifold Flange Nut / Torque & Design Change

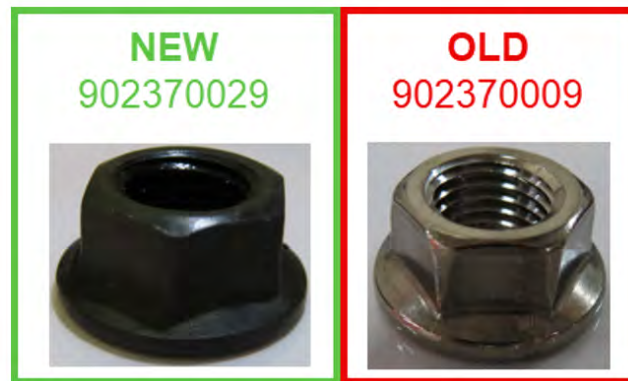
DESCRIPTION OF DESIGN CHANGE:

This bulletin announces the design change made to the exhaust manifold flange nuts. The material has been changed from a medium carbon steel to stainless steel. This change also necessitates a revised tightening torque specification. When replacement of the flange nuts is required, follow the part and service procedure information outlined in this bulletin.

NOTE: The new and old flange nuts should not be interchanged and always replaced as a set.
