SERVICE BULLETIN

APPLICABILITY: 2020-24MY Legacy and Outback
2019-24MY Ascent

NUMBER: 07-189-21R

SUBJECT: Door Window Regulator- Erratic Operation

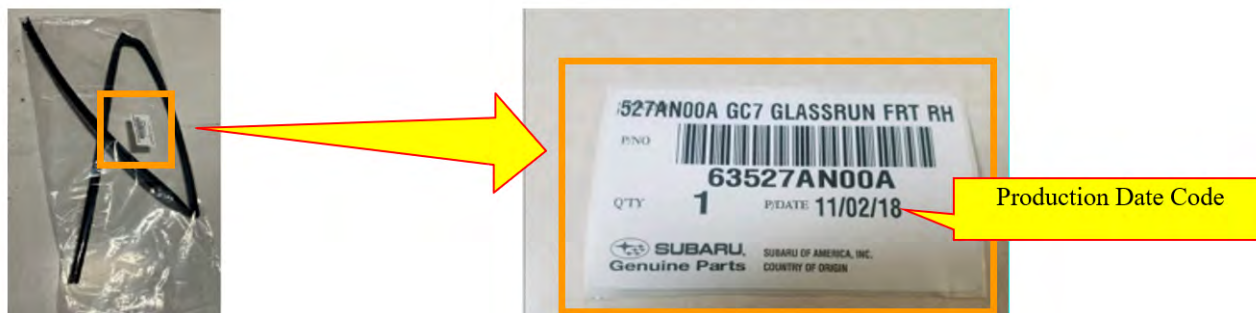
IMPORTANT: There has been no change in part number for the door glass run channel seals. The NEW parts can be identified by the six digit production date code located on the part identification label. The date code is listed in MM/DD/YY format. See the example below.

The 1st and 2nd digits of 6-digit code show production month. (The example below “11” means November.)

The 3rd and 4th digits of 6-digit code show production day. (The example below “02” means the 2nd of the month.)

The 5th and 6th digits of 6-digit code shows production year. (The example below “18” means 2018.)

If the production date is on 02/23/24 (February 23, 2024) or later, the part is incorporated with the process improvements.

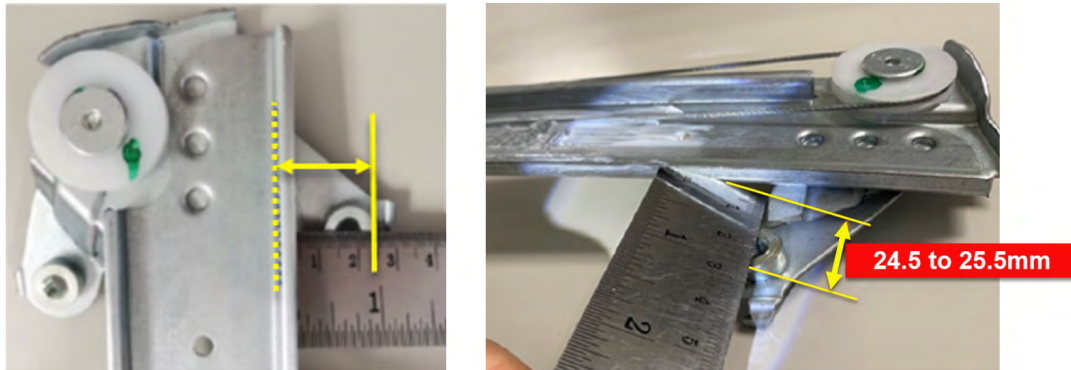
STEP 2: Measure the regulator upper roller frame to confirm the regulator was correctly assembled. If the measured distance between the outside of the rail guide (see dashed line below) and the outer side of the mounting nut is not within **24.5 to 25.5mm**, the regulator will require replacement. A 30mm wide ruler is recommended.

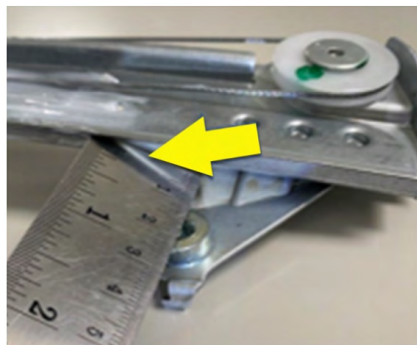
IMPORTANT NOTE: ALWAYS confirm there is no gap between ruler and the frame.

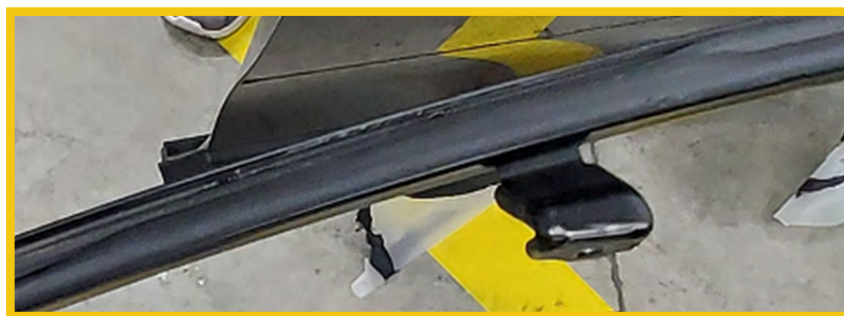
STEP 3: When inspection determines window regulator replacement is required, the door glass run channel seal will also require replacement. See the example photo below of the door glass run channel seal.

The service procedures for window regulator assembly and door glass run channel replacement remain unchanged. Always refer to STIS and review the full requirements of the repair being performed. The Service Manual procedures contain information critical to performing an effective repair the first time, every time. This includes but is not limited to important SAFETY precautions, proper inspection criteria, necessary special tools, required processes and related one-time-use parts needed for a complete and lasting repair.
