## SERVICE BULLETIN

**APPLICABILITY:** 2010-19MY Legacy and Outback  
 2014-19MY Forester  
 2012-19MY Impreza  
 2013-19MY Crosstrek (Exc. 19MY PHEV)  
 2015-19MY WRX  
 2019-20MY Ascent

**NUMBER:** 16-103-16R

**SUBJECT:** Transmission Fluid Seepage

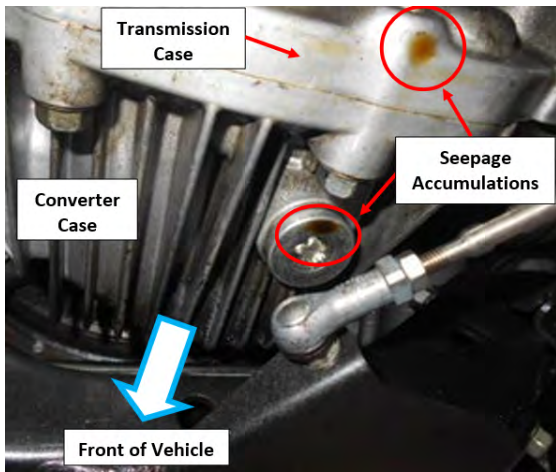
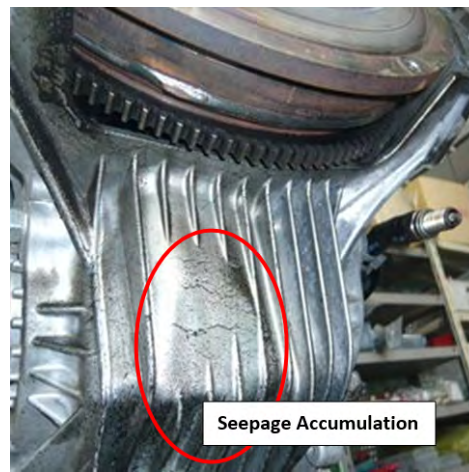
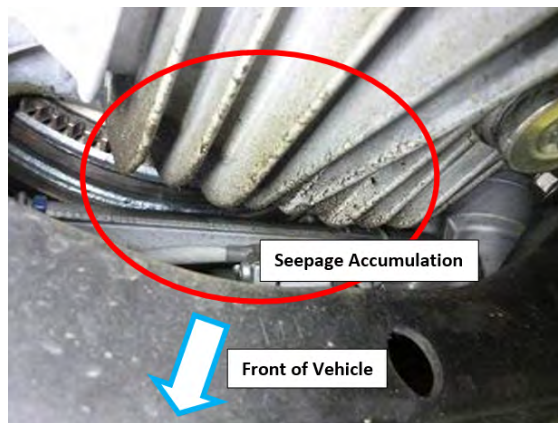
As a first step, during inspection of the customer's concern, confirm the fluid found to be seeping is CVT fluid (CVTF) and not engine oil. The photos below are examples of where CVTF seepage may be evident.

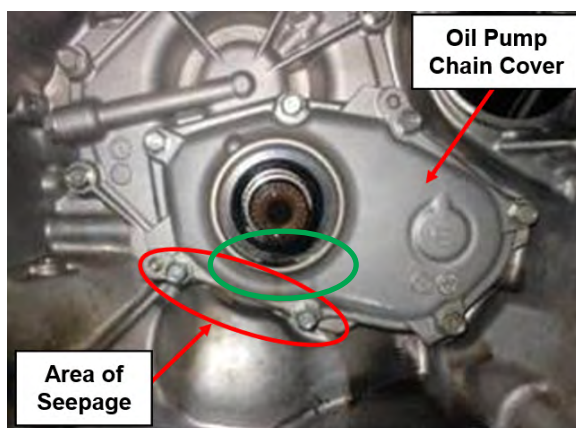
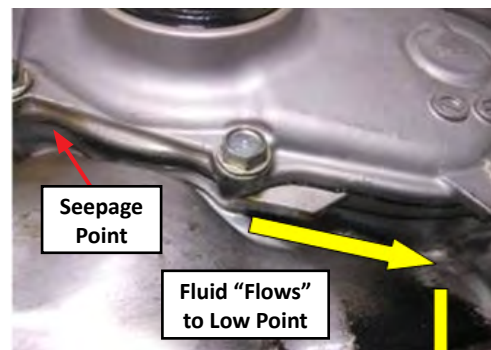
Seepage Out to Converter Case

- Once the inspection has confirmed the seepage is CVTF, remove the CVT assembly following the procedure outlined in the applicable Service Manual. **The Service Manual uses a black star (★) in the component breakdown illustrations to indicate one-time use parts.**
- **CAREFULLY** remove the torque converter from the CVT and inspect the area of the oil pump chain cover as indicated in the photo below for any accumulation of CVTF and road dirt which may also have collected in the area.

**NOTE:** A small amount of fresh CVT fluid may appear near the 6:00 position of the seal area during removal of the torque converter (GREEN circle).

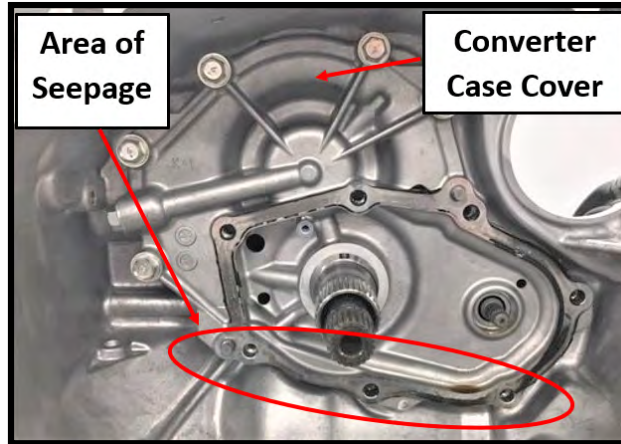
Check the mating surface of the converter case cover for CVT fluid seepage.

- If CVT fluid is found leaking in this area, remove and re-seal the converter case cover. Refer to the “**Converter Case Cover Re-Sealing**” section of this bulletin. If NO CVT fluid is found leaking in this area, continue with the procedures for re-sealing the oil pump chain cover.

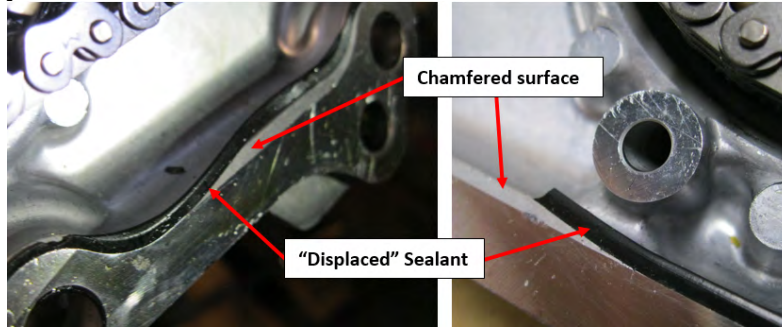
- Take note of how the sealant on the removed cover forms an additional “seal” when it becomes displaced into the chamfer around the inside edge of the case’s machined surface at assembly.

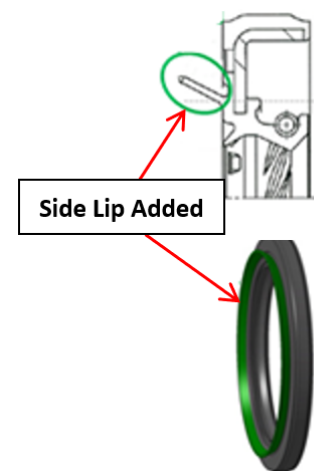
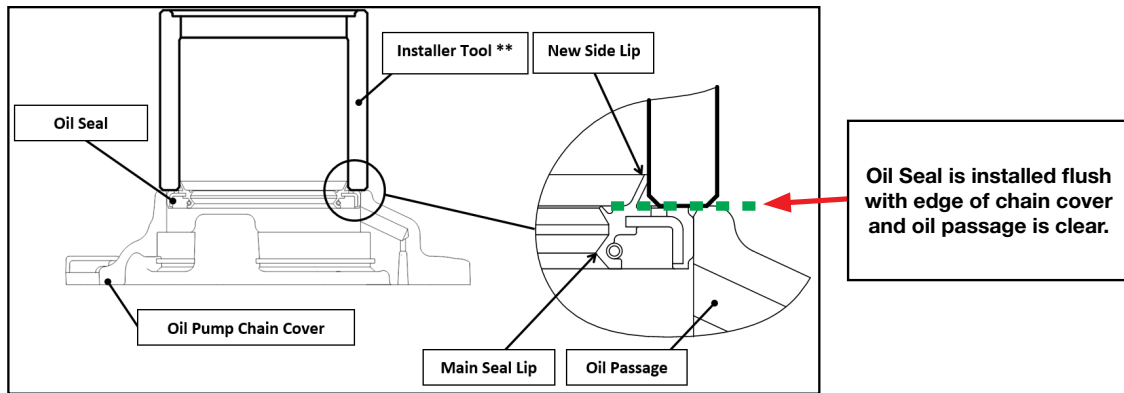
- The re-designed input shaft oil seal has a new side lip added to supplement the existing main seal lip. The purpose of the additional side lip is to direct the flow of dust and water around the seal and away from the sealing surfaces.
- Apply CVT fluid to the main seal lip **only** before installation.
- When installing this new seal, it is **STRONGLY** recommended to use the proper installer tool **\*\*OPTIONAL Special Tool 927890000** as shown in the illustration below. Otherwise, If the seal were to be installed too deep into the bore of the chain cover (beyond flush with the chain cover edge as shown below), the oil passage may become restricted or blocked.
