Service Engineering Operations  
Customer Service Division

**SUBJECT:** **Customer Satisfaction Program 23P22 – Supplement #1**  
Certain 2024 Model Year Ranger with Ford Licensed Accessory Bed Cap Added  
Load Box Reinforcement Bracket Kit Installation

**REF:** **Customer Satisfaction Program 23P22**  
Dated February 7, 2024

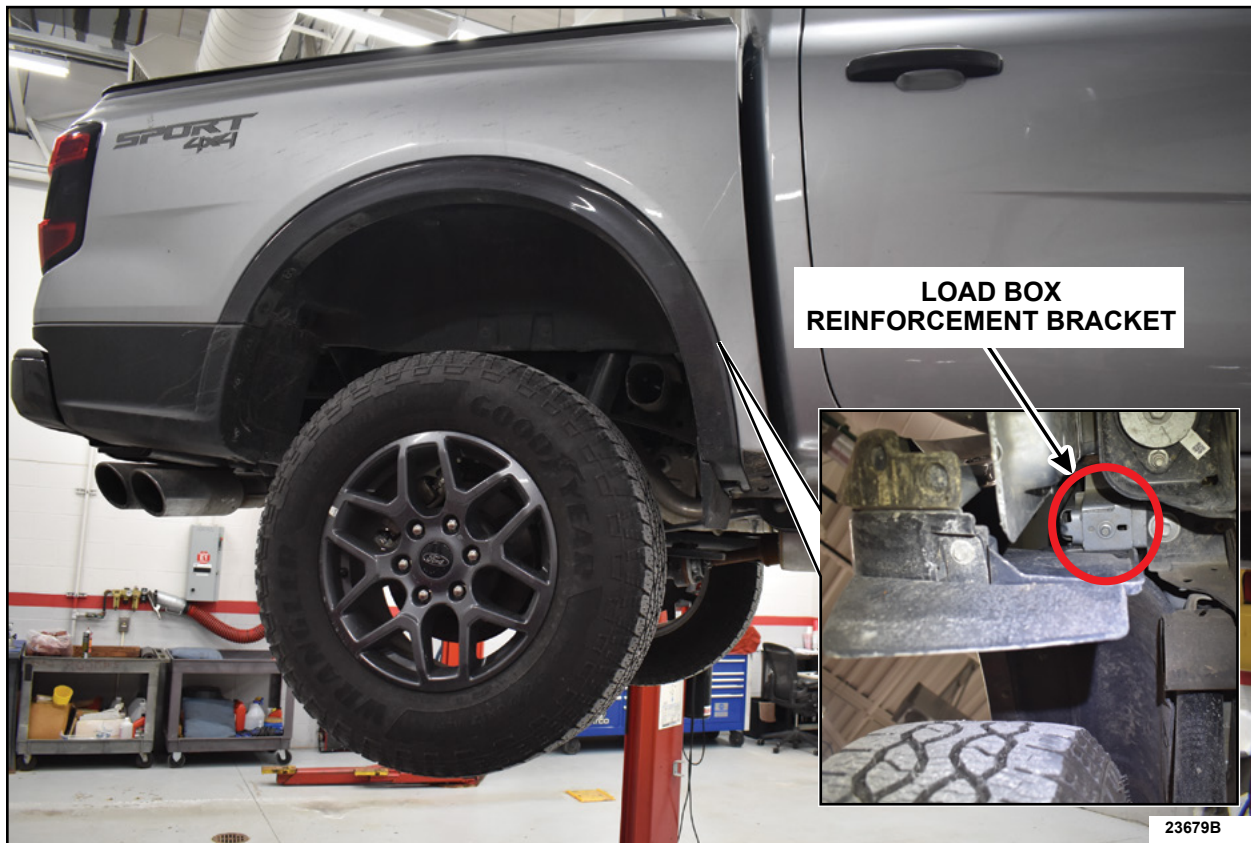
FIGURE 1

1. Position the vehicle on a hoist. Follow the Workshop Manual (WSM) procedures in Section 100-02.
2. Locate the load box reinforcement bracket installation area on both side of the vehicle. See Figure 1.

**NOTE:** Right hand (RH) side shown, Left hand (LH) side similar.

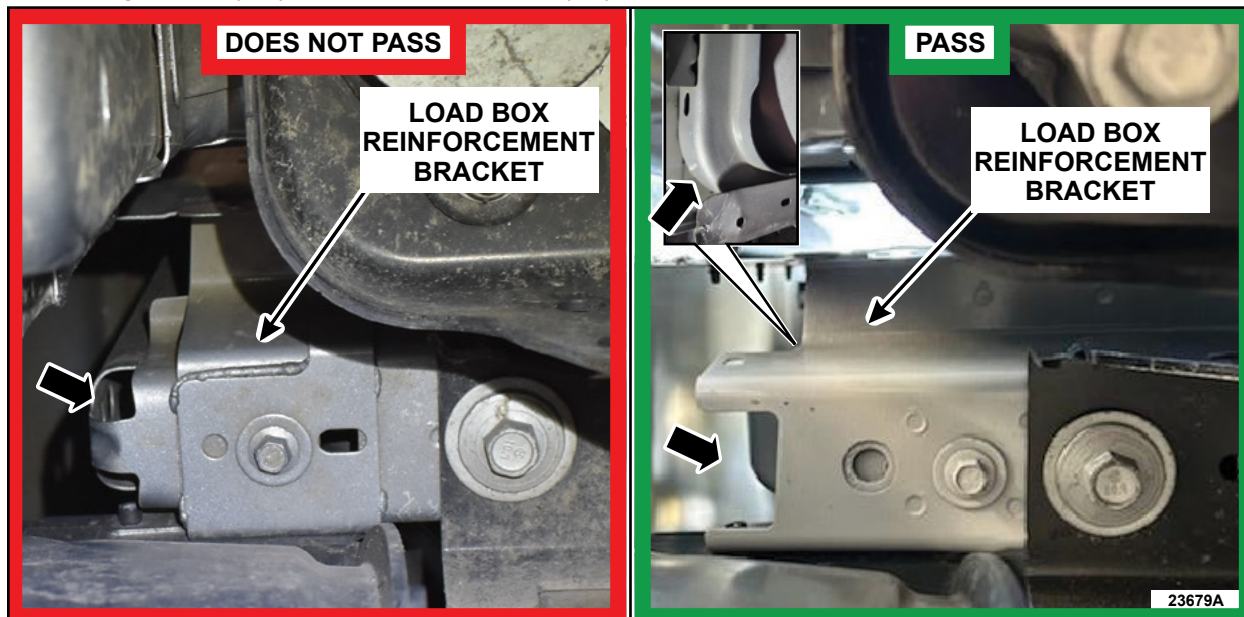
FIGURE 2

3. Inspect to see if the updated load box reinforcement bracket is present on both sides. See Figure 2.

**NOTE:** The main difference between the two brackets is the presence of holes on the corners of the bend. The updated brace has no holes and a smooth transition of the bend.

**NOTE:** Right hand (RH) side shown, Left hand (LH) side similar.

4. Install the RH and LH load box reinforcement brackets following the instructions included in the kit.
5. Submit pictures of the vehicle VIN, updated load box reinforcement brackets installed, and bed cap installed using the Mobile PTS "Report a Vehicle Concern"  
<https://m.fordtechservice.dealerconnection.com/>.
