**Document ID:** IK0400125

**Title: Rear S Cam Tube/ Bracket Part Update**

**Applies To: Prostar, CAT, LoneStar, Durastar, WorkStar, TranStar**

Part update for cast and stamped Rear S Cam Brackets. Revised parts will include an additional gusset for the rear wing bracket and/ or longer gussets and wrap-around weld on the flange side of the tube.

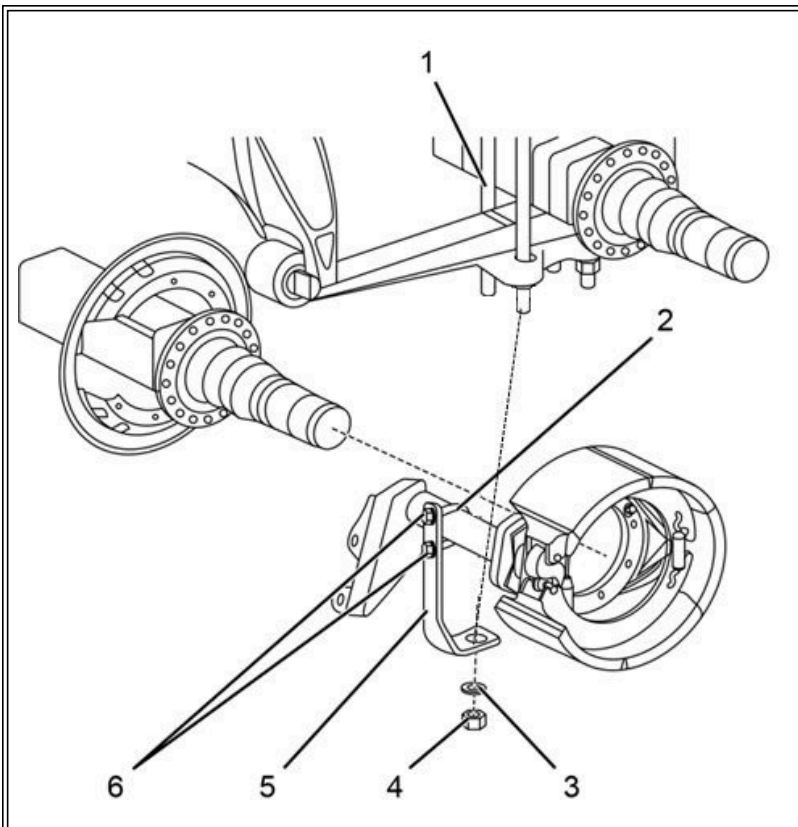
**Figure #1: Cam Tube**

**NOTE: On certain wide base axle applications the new SCAM gusseted bracket will come into contact with the old support brackets. It will be necessary to order and relocate new s-cam Support bracket to the out board side of the U-bolt (Bolt closest the wheel).**

If replacing the passenger side (right side) s-cam bracket you will need a new s-cam support bracket part # 3668032C1  
 If replacing the Driver Side (left side) s-cam bracket you will need a new s-cam support bracket part # 3668033C1

1. Remove and discard the old support bracket
2. Remove Out Board U-Bolt Nut
3. To ensure proper installation of the cam tube support bracket, perform the following:
  - a. Slide the new cam tube support bracket (Figure 1, Item 5) over the outboard U-bolt (Figure 1, Item 1)
  - b. Position the exhaust pipe clamp (Figure 2, Item 2) on the cam tube support bracket (Figure 2, Item 5) and through cam tube support bracket slots with two washers and nuts (Figure 2, Item 1) hand tight.
  - c. Ensure the cam tube support bracket (Figure 2, Item 5) is contacting the cam tube (Figure 2, Item 3) and is sitting flush against the rear U-bolt spring plate (Figure 2, Item 4).
  - d. Using a torque wrench, tighten two nuts (Figure 2, Item 1) to 60 - 72 lb-in (6.8 - 8.1 N•m).
