Document ID: IK0800672
Revision: 0
Created: 7/29/2024
Last Modified: 2/6/2025
Author: David Horner

Title: Bendix Wingman Fusion FLR25- Cruise Inoperative or SPN 61447 FMI 14 or SPN 61453 FMI 14 or SPN 61461 FMI 14

Applies To: Units built 12/20/2022 - 11/11/2024 On the following models with Feature Codes: CE Bus- 0510234 LT RH- 001MBS & 0510234 LT RH- 008TRR or 0510234 & 001LRM or 001LRV or 001LRN or 001LRL

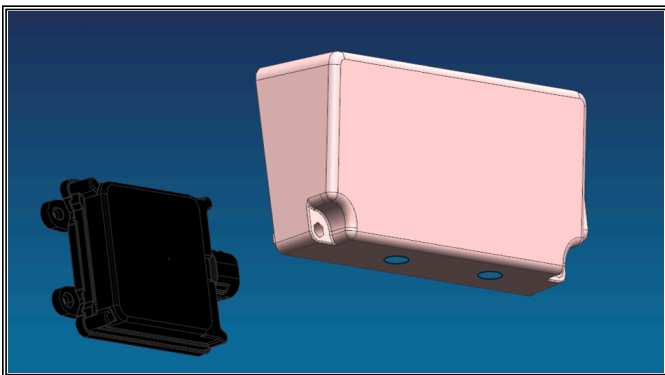
This document will guide the technician through diagnosing vehicle operator reported symptoms listed below related to Bendix Wingman Fusion where technicians have found evidence of moisture behind the Forward Looking Radar (FLR) cover on vehicles equipped with Bendix FLR25 according to the body feature codes in the title area applies to section above

1. Remove radar cover
2. Unplug FLR connector
3. Inspect FLR and harness for terminal damage and repair as needed
4. Drill 2 3/8" holes in the bottom of the cover

- 5. Clean face of cover & radar with a shop rag
- 6. Reinstall cover
