STAR ONLINE PUBLICATION

Case Number: S2408000070 Rev. D

Symptom/Vehicle Issue: Vehicle Does Not Respond to Lock/Unlock Button Presses From Keyfob and “Key Not Detected” Message is Displayed on the Cluster When Starting, No Start

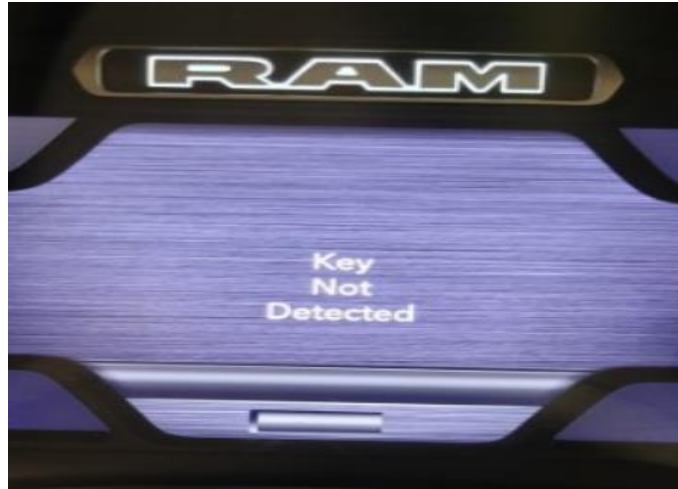
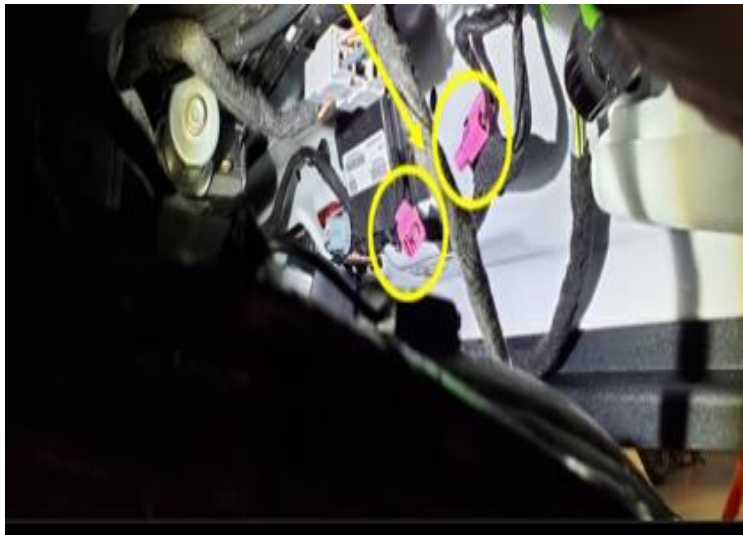
Pg 1

Inspect the remote start antenna connector at the driver side rear headliner area.
Secure as needed.

6. At the rear driver headliner inspect the remote start antenna connections and ensure the connector is securely connected.
7. Inspect the C2 RFHUB connector, verify no spread terminals and no terminals are pushed out, secure connector C2.
