Service Alert

Mazda North American Operations
Irvine, CA 92618-2922

Subject: MAZDA CONNECT INTERMITTENT AUDIO NO SOUND AND/OR STATIC NOISE FROM SPEAKERS	Service Alert No.: SA-008/25
	Last Issued : 02/04/2025

2020-2024 CX-30
2019-2024 Mazda3

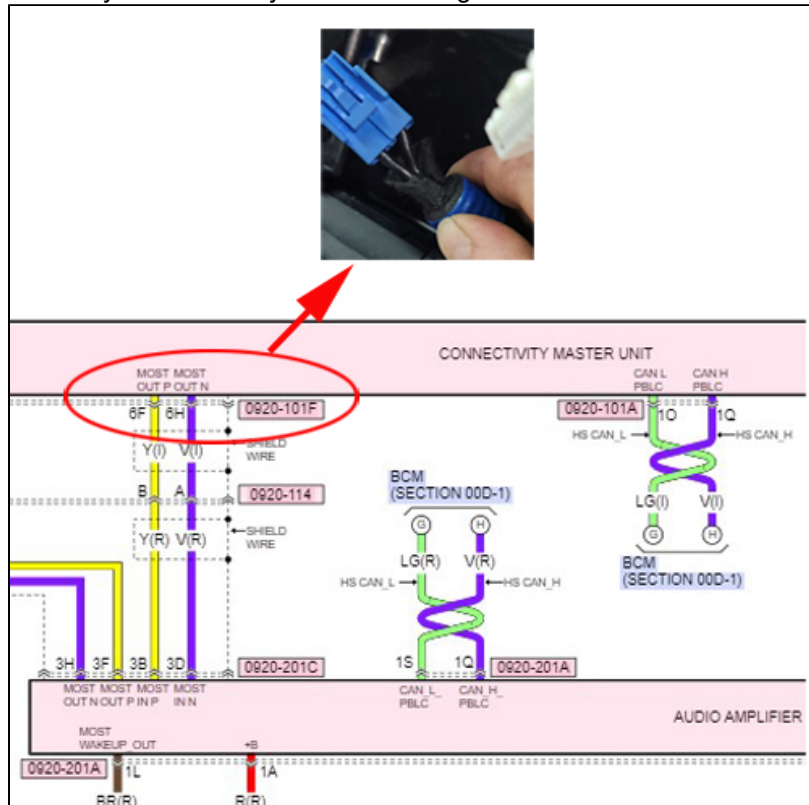
Some customers may complain about intermittent audio no sound from the MAZDA CONNECT infotainment system and/or static noise from the speakers. The concern may be reproduced by tapping on the dash pad near the MAZDA CONNECT center display and the following DTC's may be stored.

This may be caused by PIN 6F backing out at the CMU connector 0920-101F.

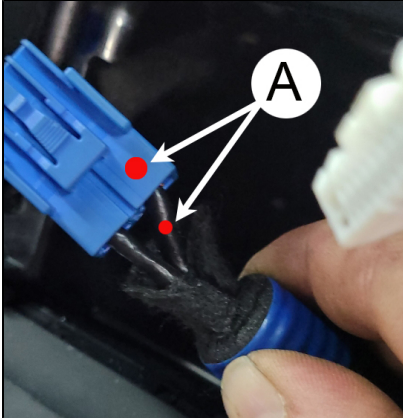
PIN 6F is backed out	PIN 6F is untwisted and repaired

5. Untwist pins 6F and 6H (straighten) and reinstall them into connector 0920-101F.

6. Pull on pins 6F and 6H to confirm they are locked and secured.

7. Confirm paint mark (A) alignment.
