Service Alert

MAZDA CONNECT SYMPTOM TROUBLESHOOTING (7TH GENERATION VEHICLES)

Service Alert No.: SA-012/25

Last Issued: 02/27/2025

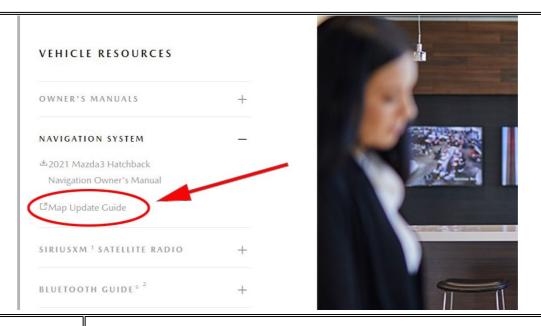
License Error message in Mazda Toolbox

Customer is locked out of map update on Mazda Toolbox due to unauthorized or counterfeit navigation SD card.

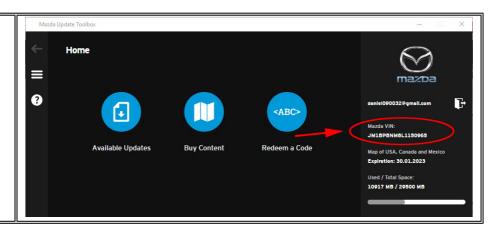
Navi SD Card VIN Locked (VIN is present)
