**February 19, 2025**

**Warranty Extension: 2016-20 HR-V CVT Premature Belt Deterioration**Supersedes 21-047, Dated April 29, 2023, to revise the information highlighted in **yellow**.**APPLIES TO**

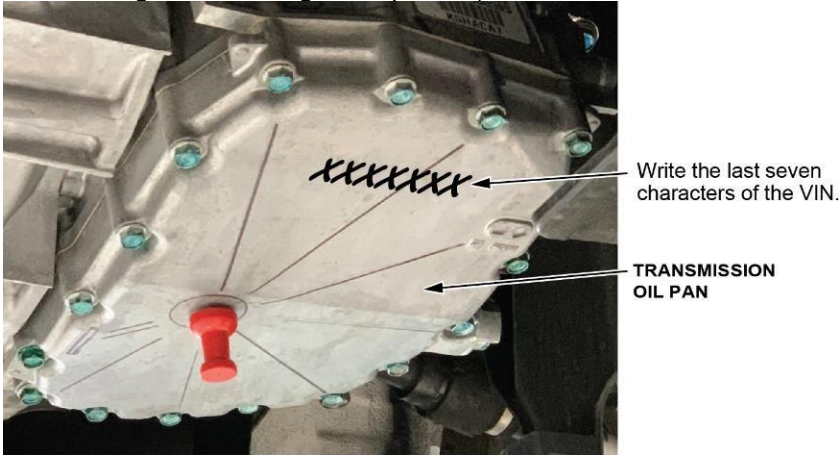
- Provide a clear picture of the magnet sticking on the CVT oil pan at the inspection area (this picture should have been taken during the CVT magnet inspection). Also, write the last seven characters of the VIN on the transmission oil pan.

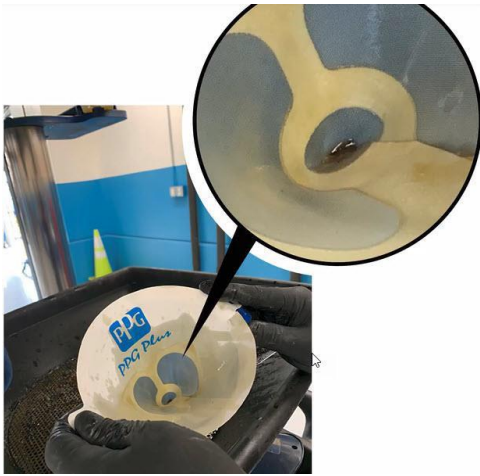
- Drain the CVT fluid through a paint strainer as shown below. Provide a clear picture of the inside of the strainer showing any contamination.

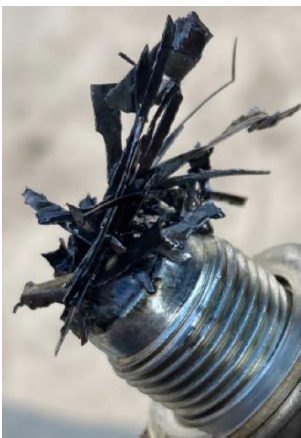
- Provide a clear picture of any contaminants on the end of the oil pan drain plug.
