February 18, 2025

Version 2

Rear Differential Pump Motor Connector Corrosion Sets AWD DTCs

Year	Model	Trim Level	VIN Range
2015-20	TLX AWD	ALL	ALL
2016-20	MDX AWD Non-Hybrid	ALL	ALL

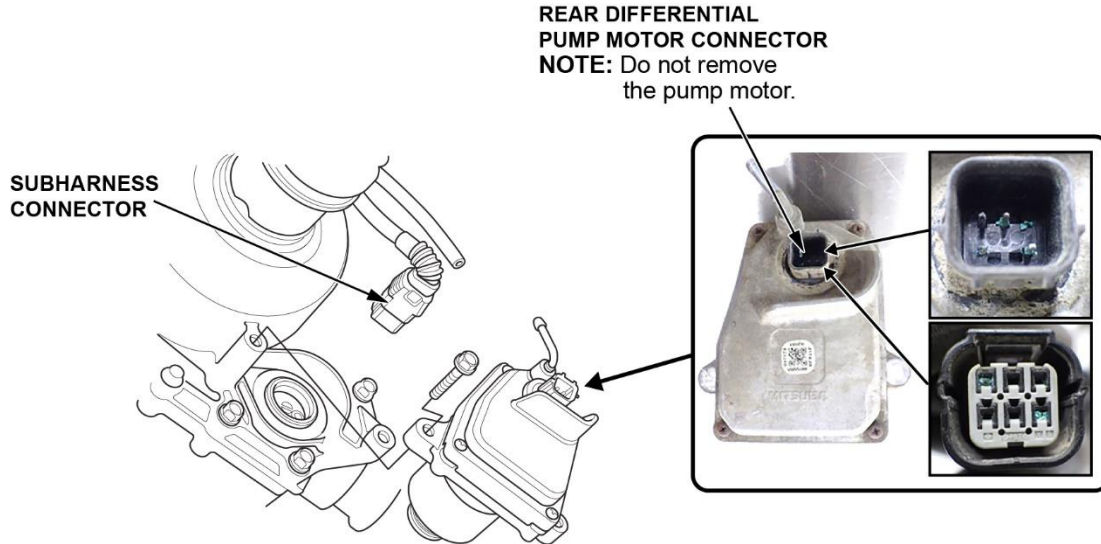
Water intrusion into the electric oil pump motor connector area corrodes the terminals.

1. Put the vehicle on a lift and position the lift pads under the vehicle's front support points and rear support points.
 - 2015–20 TLX - [Lift and Support Points](#)
 - 2016–20 MDX - [Lift and Support Points](#)
2. Inspect the connectors at C125 (Rear Subframe Harness to Rear Differential Pump Motor) for signs of water intrusion or corrosion.

Do either of the connectors have any signs of water intrusion or corrosion?

If the DTCs listed in SYMPTOM are present, replace the rear differential pump motor and rear subframe subharness.
