## STAR ONLINE PUBLICATION

**Case Number:** S2423000034 Rev. A

**Symptom/Vehicle Issue:** Defroster Grille Has Gaps And Or Is Not Sitting Flush.

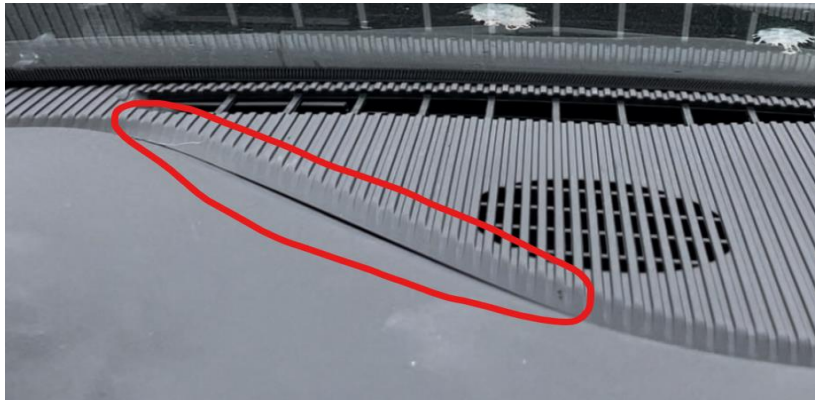
Fig 1.  
Gap At Middle Of Defrost Grille.

- 7.) If gaps are present in the center of the defroster grille proceed to step 8.
- 8.) Using the trim stick remove the defroster grille from the vehicle.

- 9.) Inspect the defroster grille for broken or bent clips. Replace the defroster grille if damage is present. If no damage is present proceed to step 10.

- 10.) Reinstall the defroster grille by starting with the center 4-way locator. This clip is in the center left of the defroster grille. (Fig 5)
- 11.) Once the 4-way is installed secure the clips starting at the center and working your way to the ends for both the left and right side.

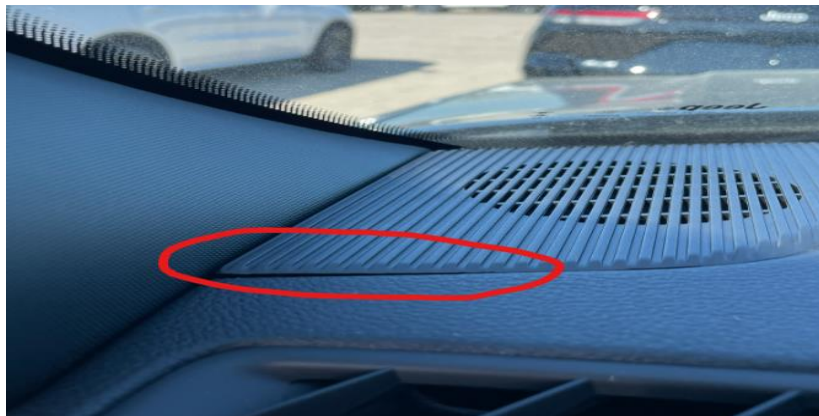
Fig 2  
Gap In Corner(s) Of Grille.

- 3.) Using the trim stick remove the defroster grille from the vehicle.
- 4.) Inspect the clip slots near the suspect location for any excessive flash or glass material. See Fig 4 below.

- 5.) If excessive material is found, remove the excessive material by carefully using a hobby knife.
- 6.) Reinstall defroster grille and validate the clip now fully seats and there is no visible gap.

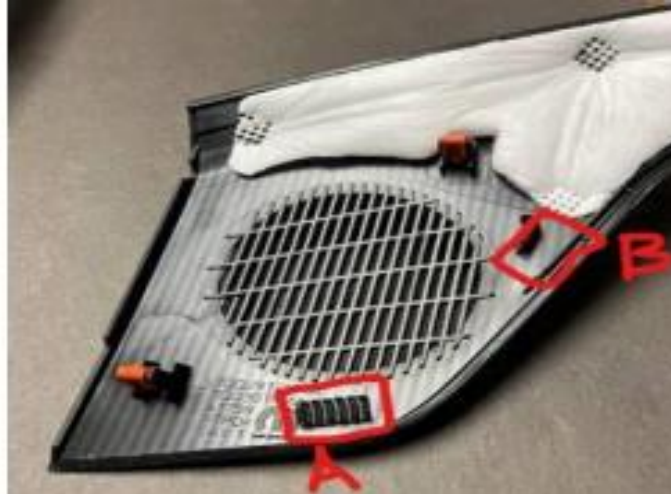
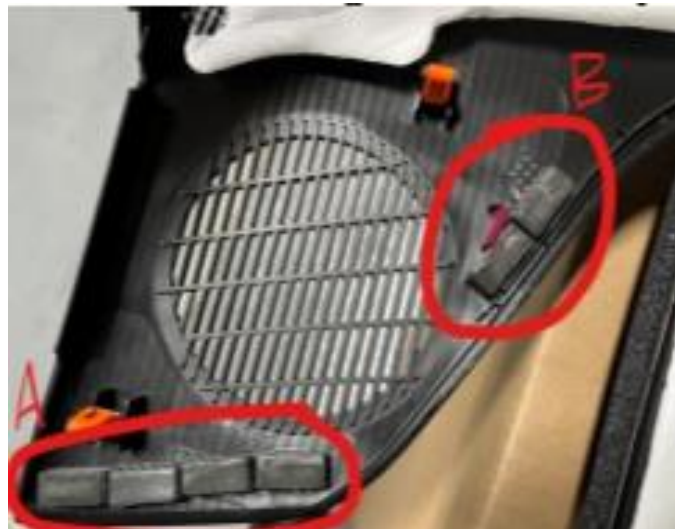
Fig 3

Velcro Application Top Image. Tape Application Location Bottom Image

- 12.) Inspect the defroster grille for any gaps. If there are no gaps present, repair is complete.
- 13.) If the gap is still present, remove the grille, use MOPAR 68620879AA Velcro or a commercially available double-sided tape such as 3M 5952 VHB tape applied in the spot where the grille is lifting or has a gap. Clean both surfaces with isopropyl alcohol to remove any oils or surface contaminants prior to adhesive application. See Fig 3.

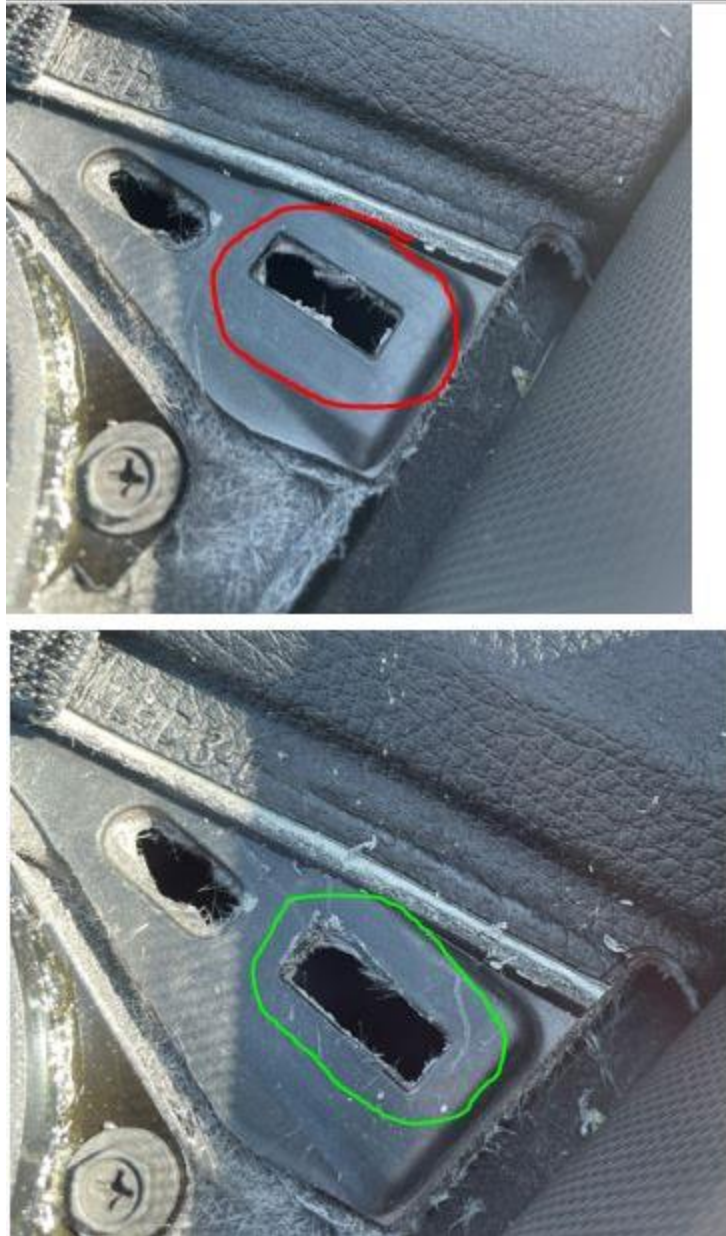
Fig 4.

Upper image hole has flash that will not allow the clips to seat. Lower image has the flash trimmed with a hobby knife to improve clip retention.

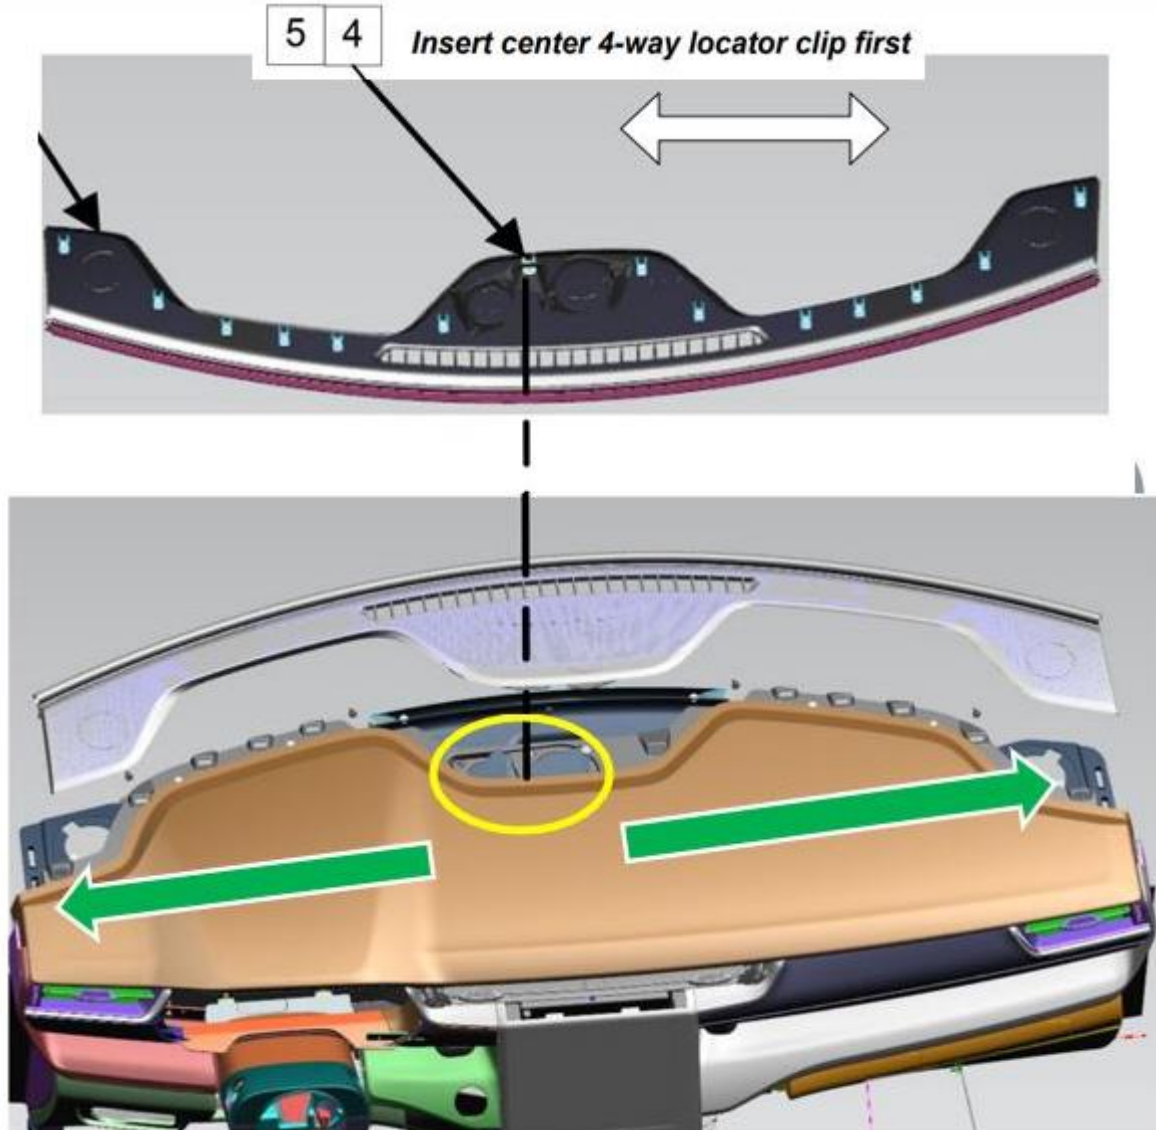
Fig 5.  
4 way locator pin location. Start at the center and work outwards when pressing/snapping the grille into position.
