STAR ONLINE PUBLICATION

Case Number: S2523000014

Symptom/Vehicle Issue: 2nd Row Seat Difficult To Latch.

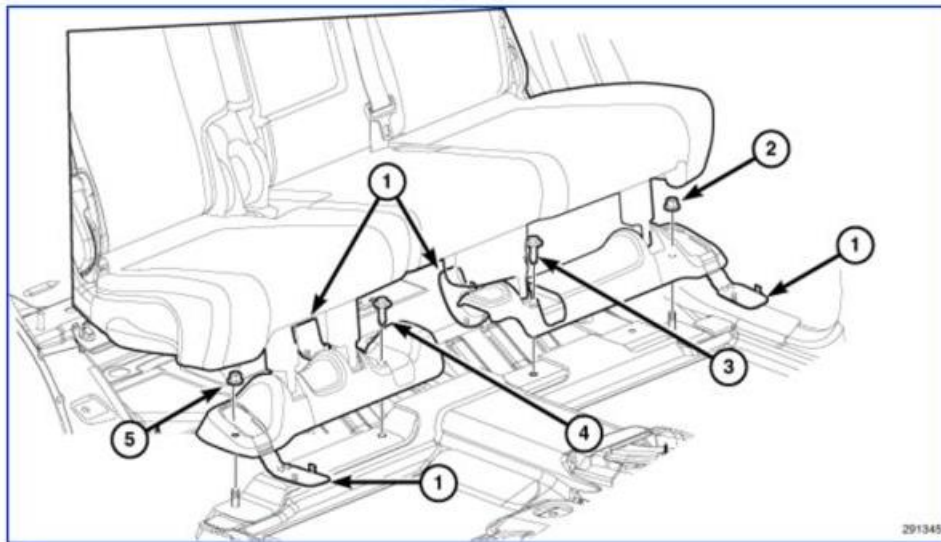
Discussion: The second-row seat may have some torsion stress on the seat frame which is requiring extra force to be required to latch the seats down. Refer to the below steps and bolt sequence. Service library is in process of an update and will reflect this information. Refer to Service Library 23 - Body / Technical Specifications for fastener torque.

1. Place the seat assembly over the 2 outboard floor mounted studs. This will locate the seat in proper floor position.

2. Install the 40% side nut (item 5 above) first. Torque to specification.
3. Install the 60% side nut (item 2 above). Torque to specification.
4. Fold the 40% seat cushion down and engage the rear latches.
5. Fold the 60% seat cushion down and engage the rear latches.
6. Install the 40% and 60% cushion bolts (items 3 and 4). Tighten to specification.
7. Verify seat operation and effort.
