Service Bulletin

Bulletin No.: 22-NA-144

Subject: Service Door Latch, Power Windows, Door Locks and Outside Mirrors Inoperative, Unwanted Theft Alarm Activation, Random Messages Displayed on Driver Information Center (DIC), Water Leak

Brand:	Model:	Model Year:		VIN Breakpoint:		Engine:	Transmission:
		from	to	from	to		
GMC	HUMMER EV P/UP	2022	2025				
	HUMMER EV SUV	2024	2025

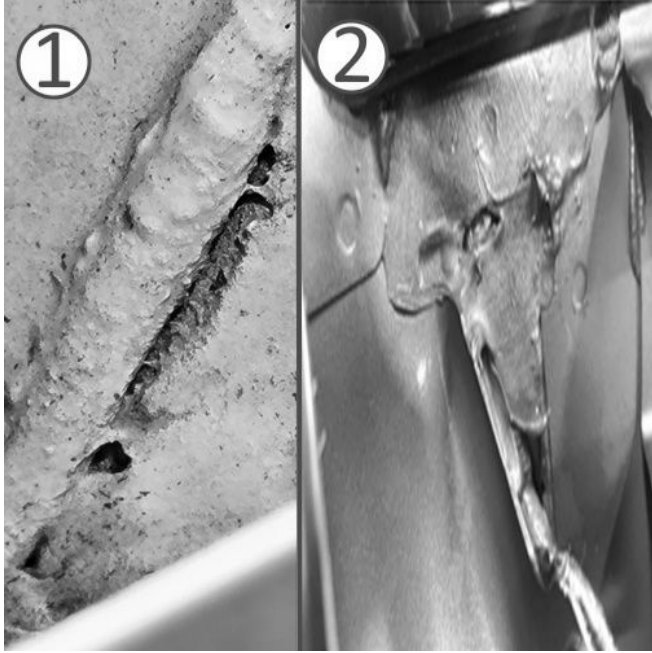
<p>Note: The image above depicts a close-up of a failed seal below the driver side (1) and passenger side (2) windshield area. 6103692</p> <p>This condition may be caused by the driver's front door X500 in-line electrical connector and/or the passenger front door X600 in-line electrical connector, that may have corroded terminals due to a water leak entering inside the upper A-pillar through the panels not sealed properly.</p>
<p>Correction</p>	<p>Open the X500 and X600 to inspect for corroded terminals. Perform a water leak test on suspected sheet metal area, reseal, and re-test for leaks.</p> <p>Repair and/or replace the X500 and/or X600 terminals as required.</p>

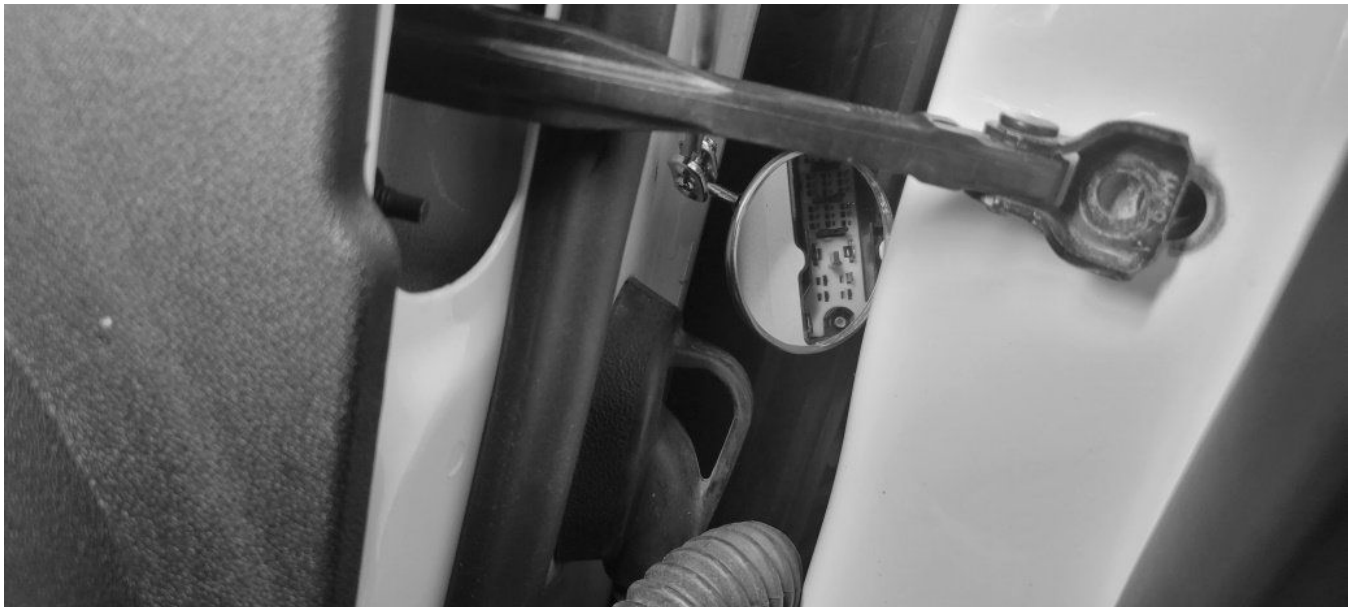
6104518

Note: The graphics above are an example of what the corrosion may look like in the X500 connectors, X600 similar.

3. Remove the X500 or X600 connector cover (1).
4. Disconnect the electrical connector.
5. Inspect the door side connector terminals for corrosion.

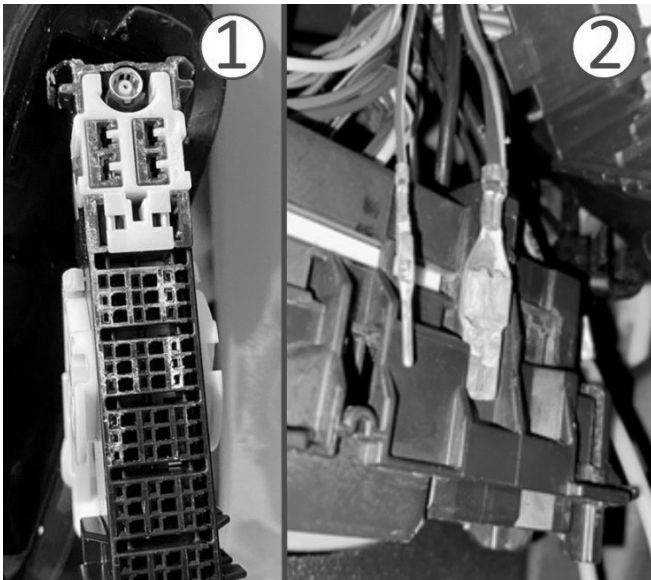
6103827

- If corrosion is found at the door side connector (1) or the instrument side connector (2), continue to step 7.
- If corrosion is not found on the connectors, refer to step 14.

6. Utilizing a mirror or equivalent, inspect the A-pillar side connector terminals for corrosion.
