Service Bulletin

Bulletin No.: 24-NA-102

Subject: Park Assist Disabled/Non-functional

Brand:	Model:	Model Year:		Build Date:		RPO:	Transmission :
		from	to	from	to		
Chevrolet	Blazer EV	2024	2025			UD7	
	Equinox	2025				UD5/UD7	
	Equinox EV	2024				UD7	
	Traverse	2025				UD7	
GMC	Acadia	2025				UD7	
	Terrain	2025				UD7

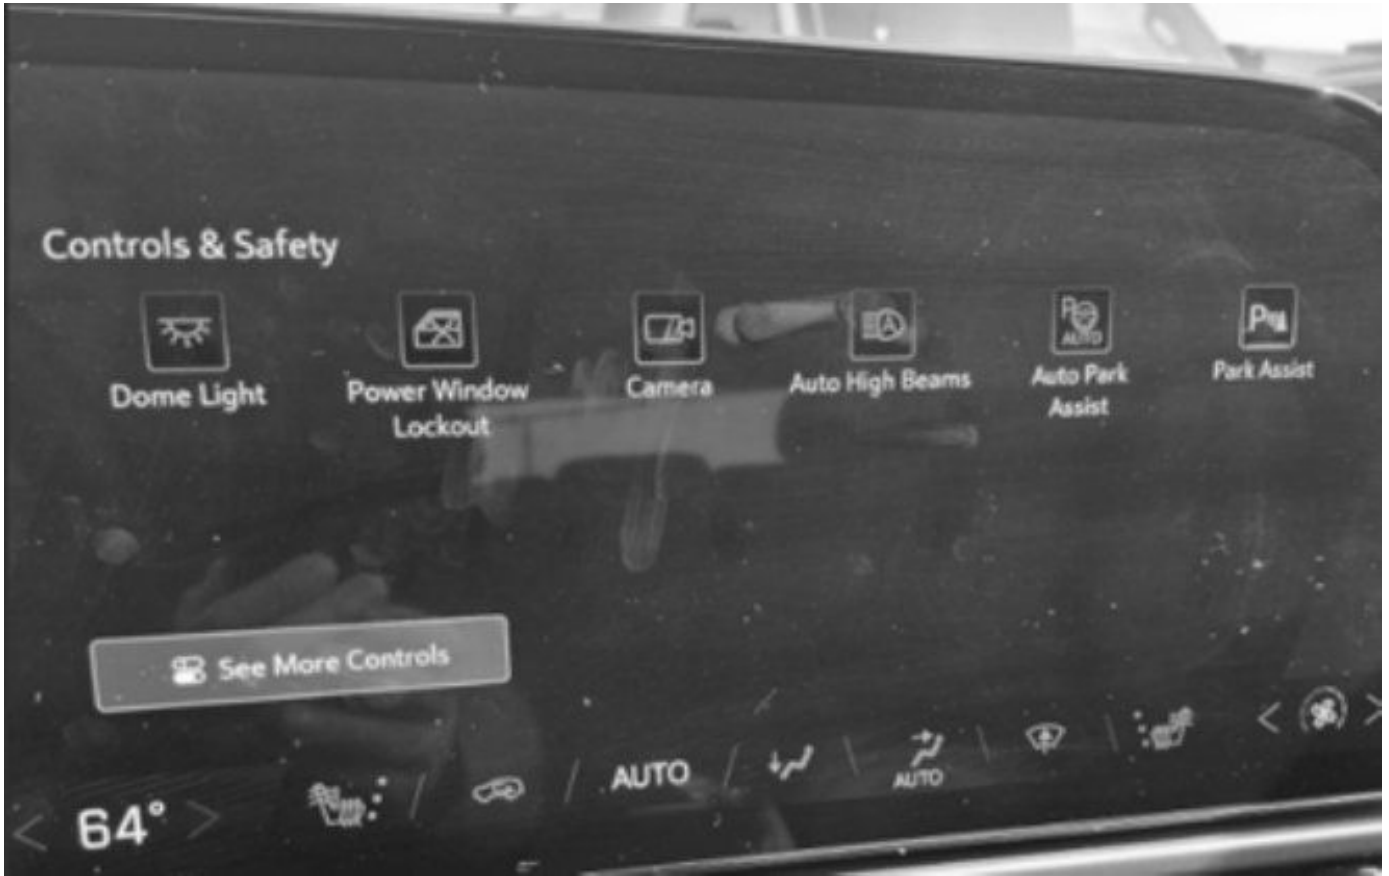
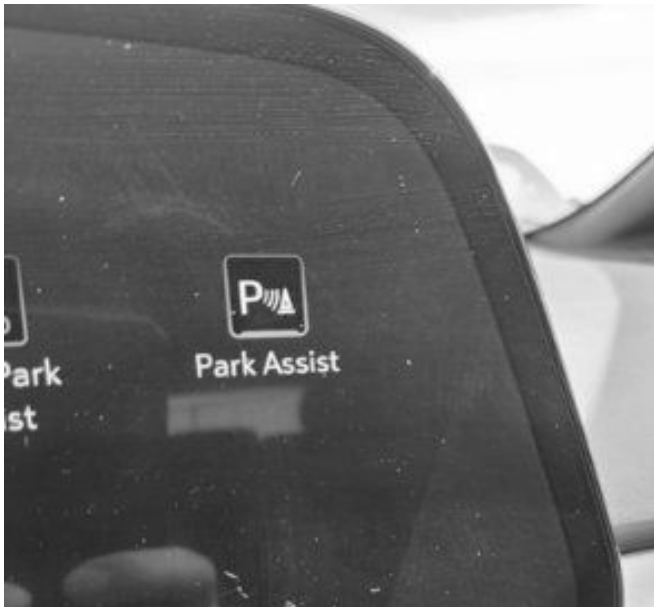
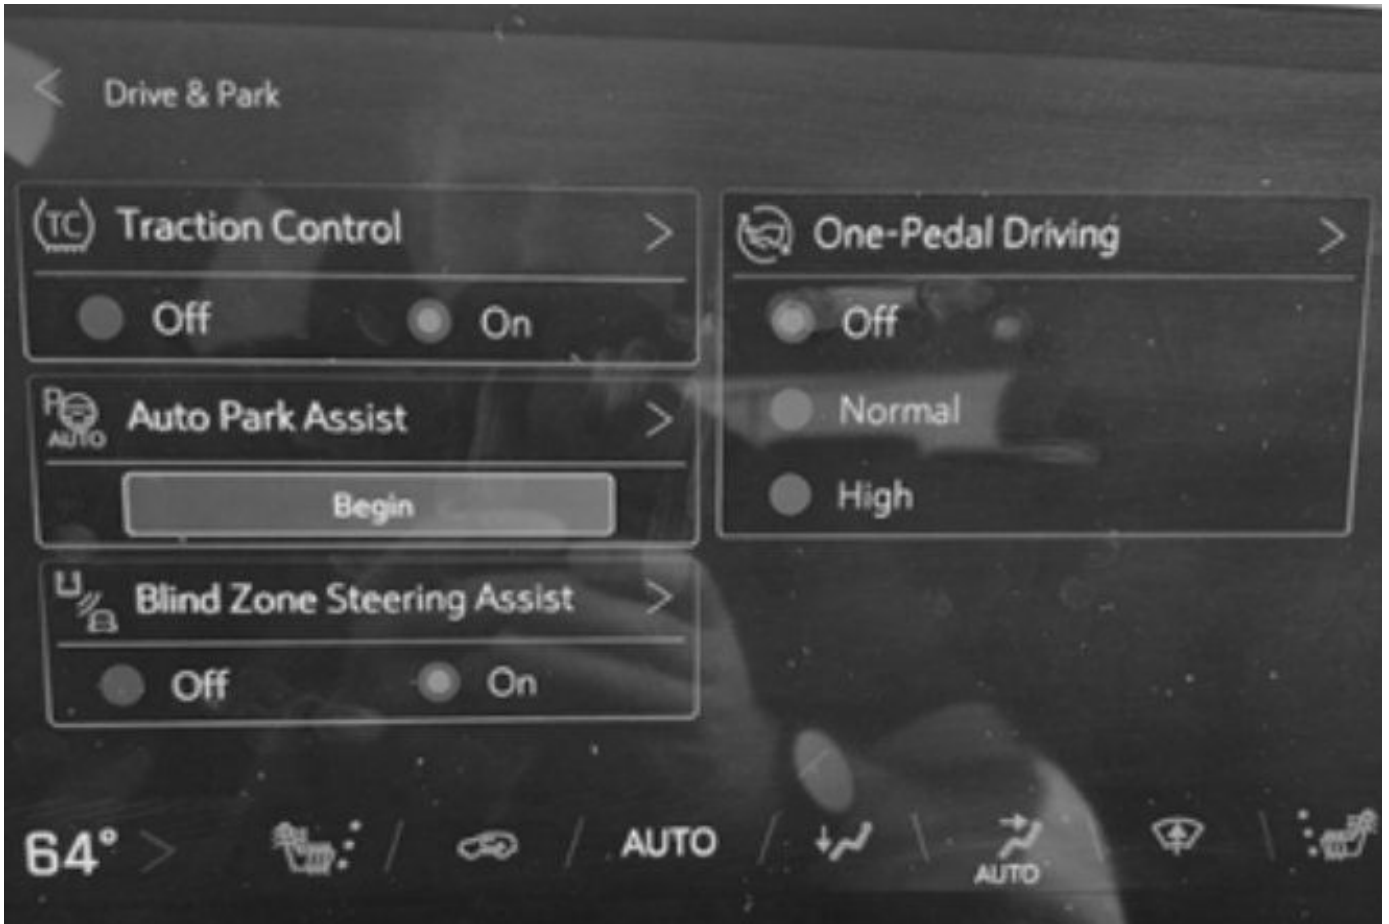
Visuals below show what this button icon looks like and where to find it on the Infotainment screen:
