Service Bulletin

Bulletin No.: 25-NA-040

Subject: Second Row Executive Seat Does Not Move with C-Pillar Button or Virtual Switches

Brand:	Model:	Model Year:		VIN:		Engine:	Transmission:
		from	to	from	to		
Cadillac	Escalade IQ	2025	2025

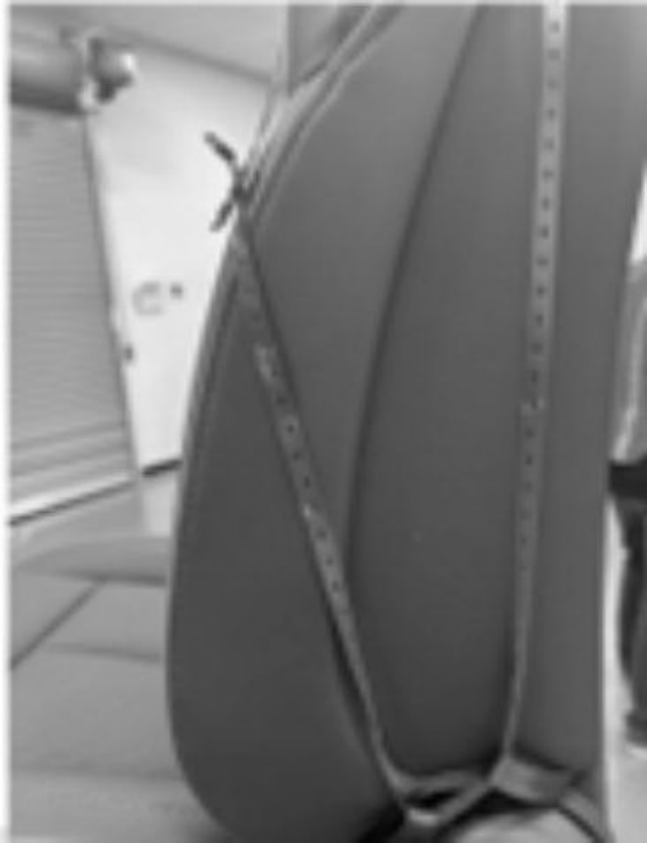
<p>Cause</p>	<p>The causes of the condition may be the blue strap that comes from the factory hasn't been removed. Failure to remove the strap before using the seat controls can result no seat movement due to the strap inadvertently pulling one of the emergency release tethers which can cause the micro-switch to open which prevents seat movement.</p>

<p style="text-align: right;">6850623</p>
<p>Correction</p>	<p>Remove the blue strap and re-try the power seat controls. If no movement, push the seat back rearward until it locks into place and re-try the power seat controls.</p> <p>Note: The C-Pillar mounted seat switches will time out (power down) after 2 minutes if any of the doors are left open, including the etrunk and lift gate. To re-energize the C-Pillar seat switches, press any key fob button or open/close any door.</p>
