**Assessment of Oxidized Cylinder Liners (SY 223/24)**

Model Line: **718 (982)**  
**911 (991)**  
**911 (992)**

Concerns: **Cylinder liners with PTWA (Plasma Transferred Wire Arc) coating**

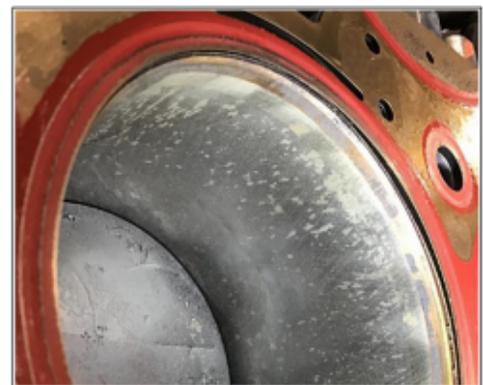
*Sample illustration of oxidized cylinder liner*

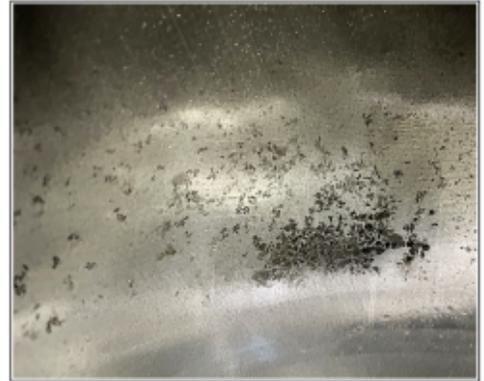
*Sample illustration of oxidized cylinder liner*

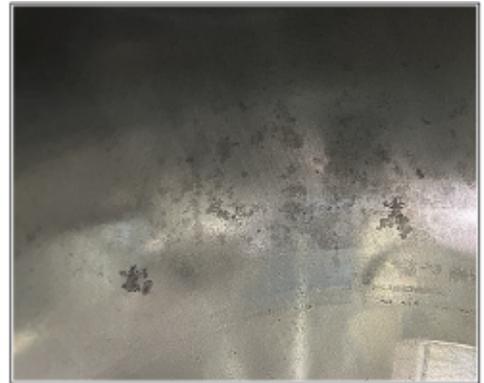
*Sample illustration of oxidized cylinder liner*

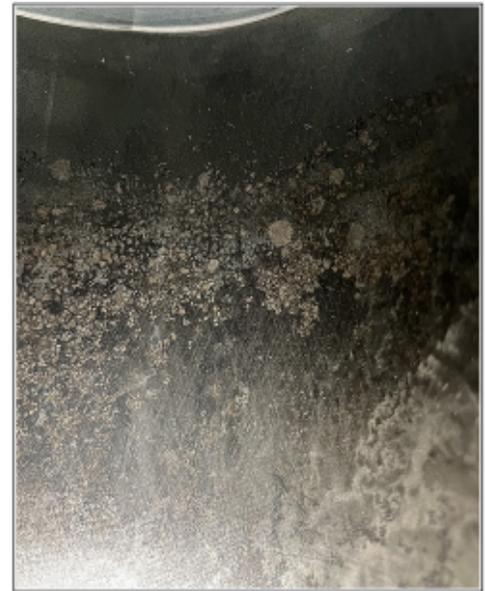
*Sample illustration of oxidized cylinder liner*
