**Flashing Function for Auxiliary Headlights Faulty / Fault Memory Entry "C11A401" in Control Unit for Headlight Bulb: Re-Code Control Unit for Headlight Bulb (231/24)**

Model Line: **Cayenne (9YA / 9YB)**

Model Year: **As of 2019 up to 2023**

Equipment: Basic LED headlights (M-No. 8IT)

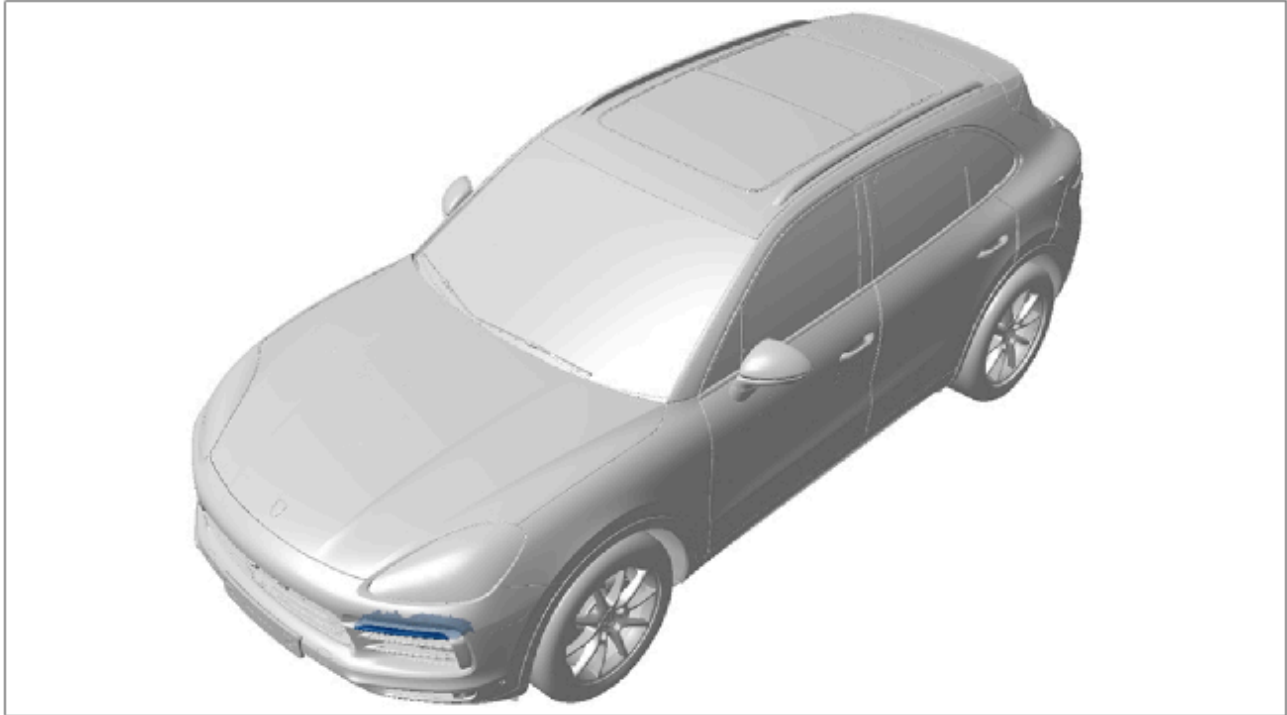
The right auxiliary headlight is mainly affected by this complaint.

Root Cause: If the vehicle electrical system voltage is low, a short circuit can be wrongly diagnosed due to excessively high voltage and current limits set within the control unit for the headlight bulb. As a result, the flashing function of the auxiliary headlight is deactivated by the headlight bulb control unit.

*Installation position of auxiliary headlight*

Action: If there is a customer complaint, regardless of whether only one or both auxiliary headlights exhibit the complaint, re-code the control units for the left headlight bulb **and** right headlight bulb using the PIWIS Tester.
