Interior Symptom - Cover for Storage Tray (front) Jammed/Stuck: Reworking Storage Tray (front) (SY 232/24)

Model Line: **Cayenne (9YA / 9YB)**

Model Year: **As of 2024**

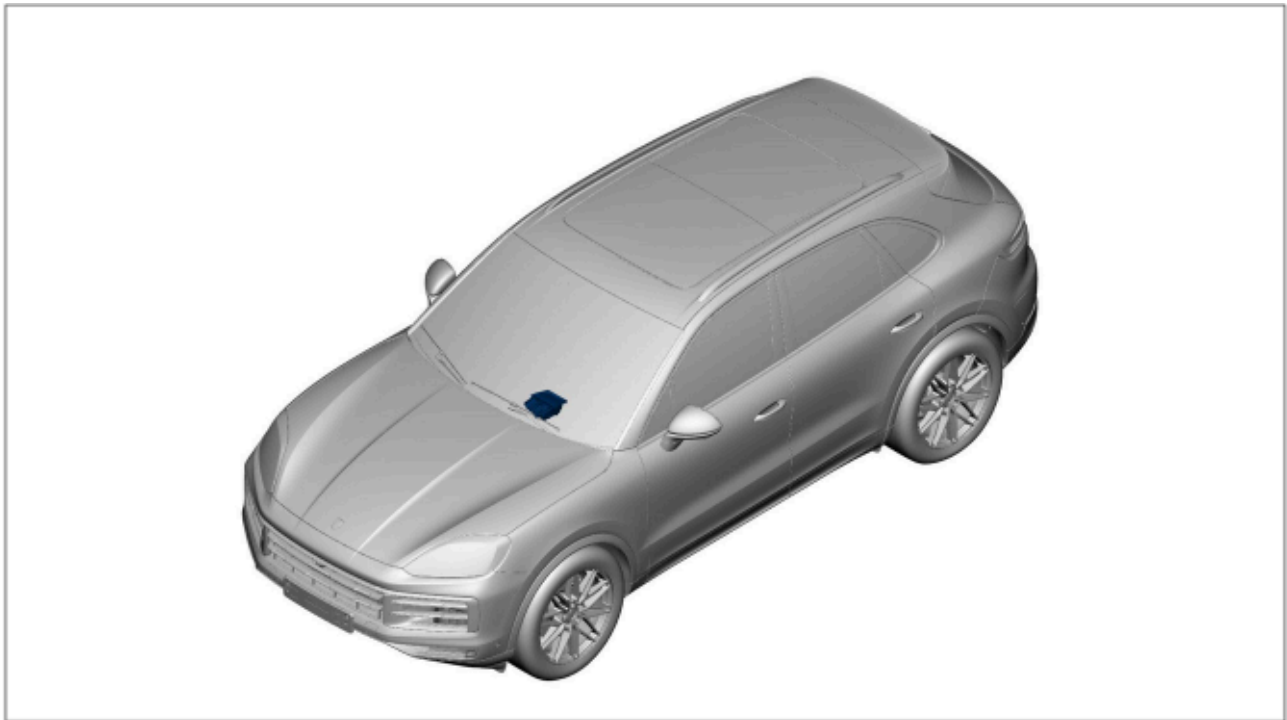
Installation position of front storage tray

Symptom: **The customer complains that the cover for the storage tray (front) gets jammed/stuck when closing and does not close properly.**
