**WPGO - Rework Roof Module Bonding (Workshop Campaign)**

Model Line: **911 (992)**

Model Year: **2022**

Concerns: **Roof assembly**

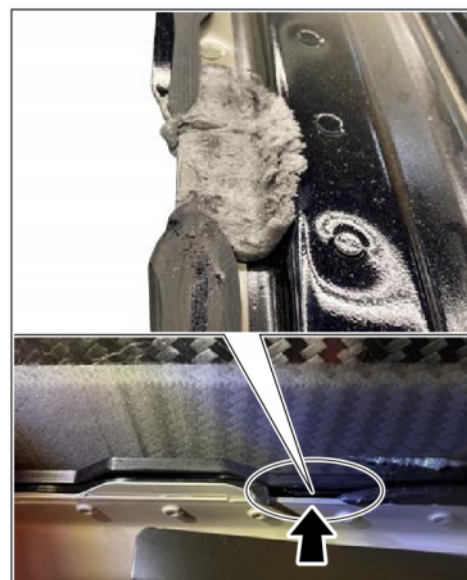
*Bonding on roof module*

Cause: **On the affected vehicles, there is a possibility that the bonding of the roof module does not completely seal against the body due to a production error.**  
If this is the case, a potential water leak cannot be ruled out.

- 11 Fill adhesive void with foam filler body.  
⇒ *Workshop Manual '5X00IN22 Processing body foam filler'*

- 11.1 Insert the nozzle into the adhesive void, spray it briefly and pull the nozzle back until foam emerges.

- 11.2 Remove fresh foam residues immediately using PU cleaner.

- 11.3 Allow the foam filler on the body to harden and remove excess foam mechanically if necessary.
