**WRG2 - Check Power Windows and Replace if Necessary (Workshop Campaign)**

Model Line: **911 (992)**

Model Year: **As of 2024 up to 2025**

Concerns: **Front power windows mechanism**

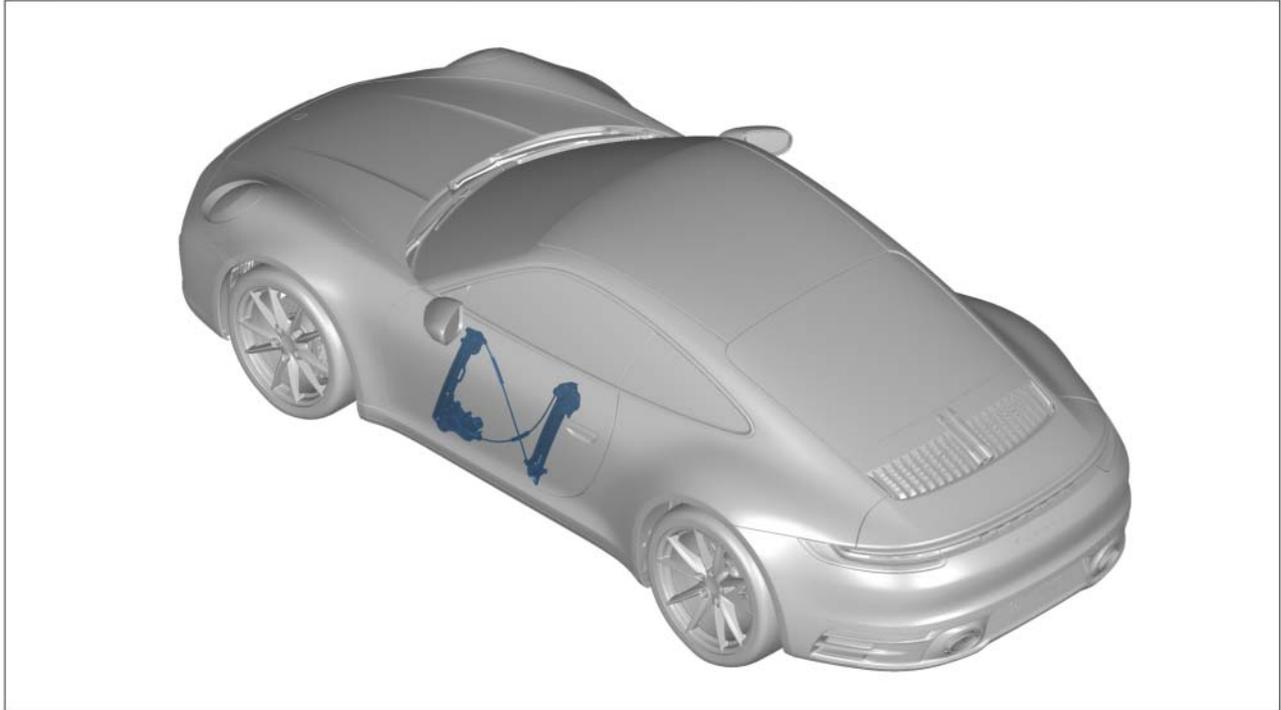
Installation  
Position:

Cause: **There is a possibility that a power windows mechanism was installed in the front doors that does not meet the required specifications on the affected vehicles.**

If this is the case, the design differences mean that the door window does not fully retract into the door.

*Installation position for front power windows mechanism (shown on the left side of the vehicle)*

Action: Check the end position of the front left and right door window and replace the respective front power windows mechanism depending on the result.
