992 Lightweight Rear Quarter Glass Panes Are Cracked

Advanced Technical Information

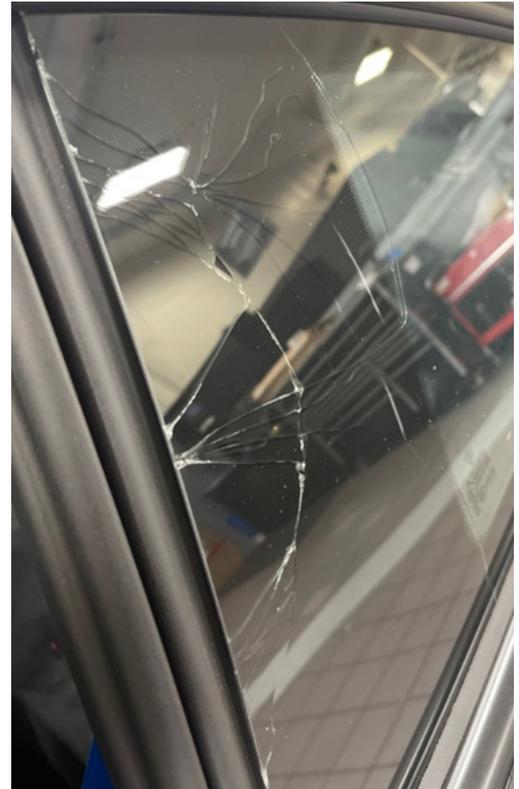
Figure 1

The customer and the workshop find cracks in the rear quarter glass (non-moveable side windowpane). These cracks are typically found toward the front of the vehicle, closer to the door. (Please see figure 1.)

There are multiple causes for this condition. Generally, these causes relate to the amount of tension on the glass during and after the repair. The most common causes are:

- The quarter glass mounting nuts are over-torqued, increasing tension on the rear quarter glass.
- The door or door glass is misaligned. This can produce a collision between the door glass and the rear quarter glass or increase tension on the rear quarter glass.
- There is adhesive leakage on the body panel slightly reducing the geometry and increasing tension.
- There is an offset between the inner and outer body panels, changing the dimensions of the opening and increasing tension.
- The adjustable bolts are out of tolerance, which increases the tension on the glass.
- Customer behavior may also be a factor that causes cracks. The customer may inadvertently strike the glass with jewelry (including rings and watches) or allow his or her bodyweight to rest on the glass pane while exiting the vehicle.

Please replace the affected glass pane(s) as instructed in *WM 647519 – Removing and installing side window (Coupe)*.
