# Service Bulletin

Bulletin No.: PIE0819

**Subject:** Engineering Information - (EI Lite)-(Pictures ONLY) for Pre-Delivery Inspection (PDI) and Customer Vehicle Issues Up to 500 Miles. Using the CSMT App do Field Product Reporting (FPR), Please Submit a Report for the Following Issues: Paint Issues or Damage (EXCEPT for Transportation), Moldings, Appliques, Emblems Loose, Warped, Crooked or Missing / Weatherstrips Misaligned, Mis-formed / Sheet Metal and/or Trim Panels Misaligned / Interior Trim Loose, Crooked, Missing / Seats, Seat Trim

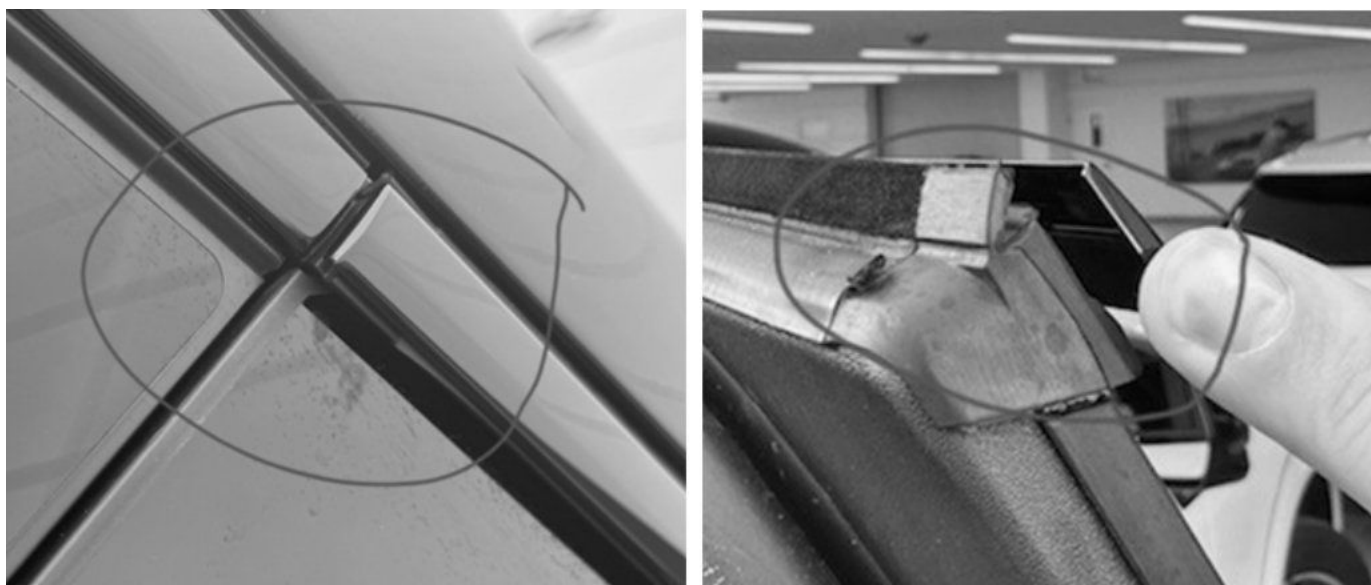
6850471

1. Shown in the picture above are examples of the entire area of the vehicle showing the location of the issue/part on the vehicle.

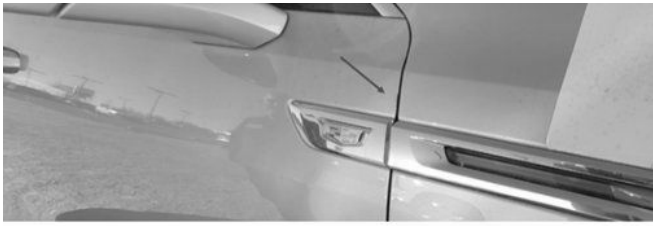
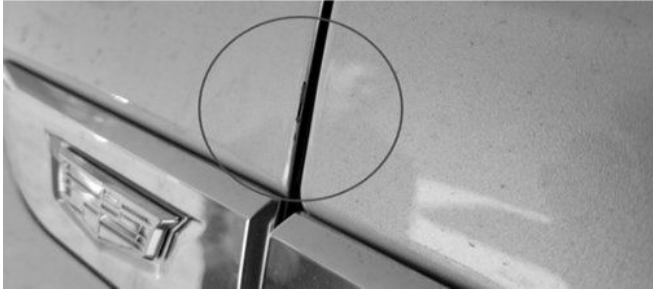
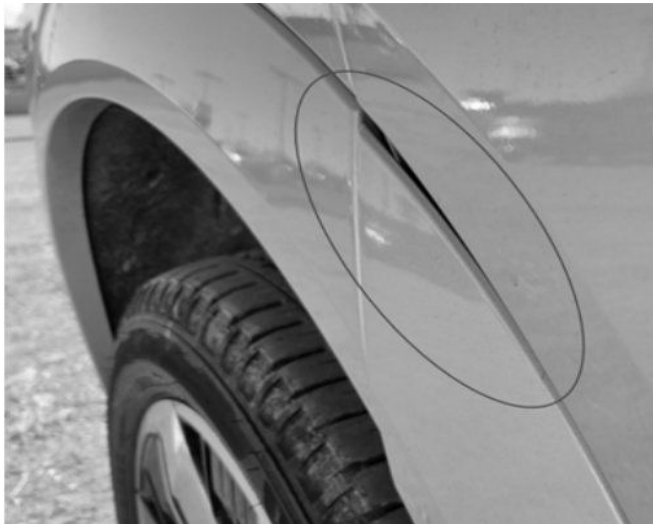
2. Shown in the pictures above are examples of clear close-up pictures to better show the detail of the issue/part.

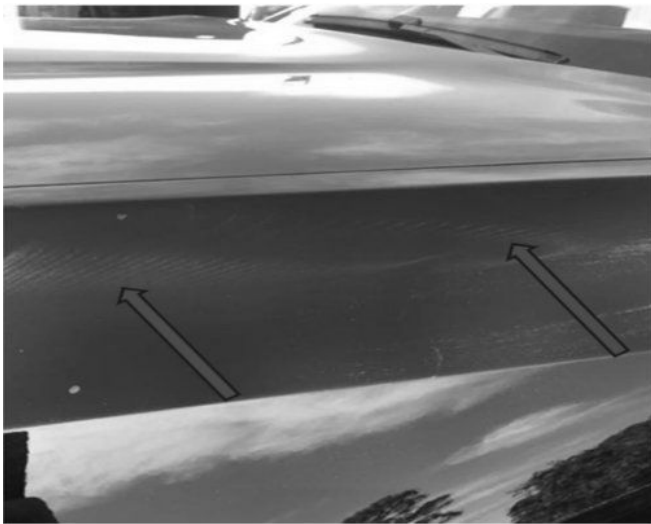
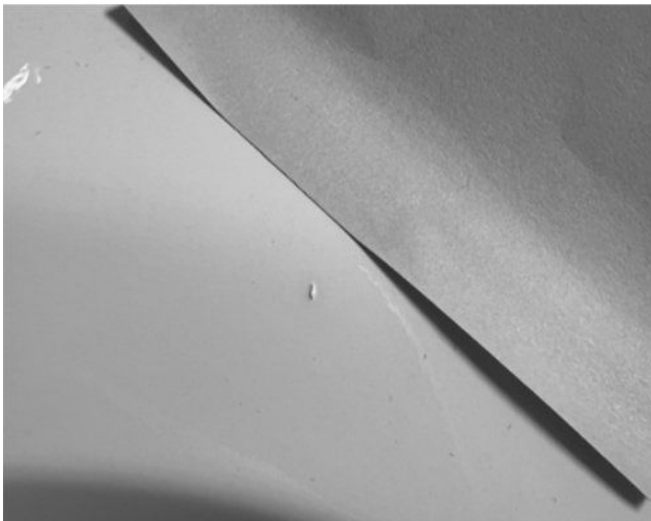
- Shown in the pictures above are examples of paint issue. When reporting paint concerns, please take wide shot of the vehicle to help orientate the location and a close-up to identify the issue.
