### Lightweight Glass Panes Cracked – Identification and Possible Causes

Models	Model Year	Model Type	VIN Range	Vehicle-Specific Equipment
911	2021 - 2025	992110 992120 991130 992140 992150 992410 992420 992430 992440 992450 992460 992810 992820 992850	n/a	+VW4

**This document only applies to vehicles with the option VW4 – Lightweight and Noise Insulated Glass.**

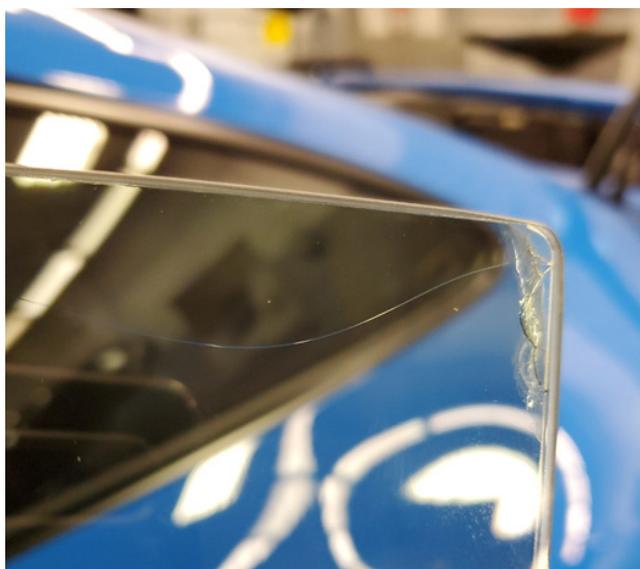
**Figure 1 - Door glass: cracks in the top corner**

There are two main causes for this condition:

- > The door glass is misaligned, which can cause contact between the door glass and the rear quarter glass, or
- > Force applied to the glass (i.e., instead of the door sill) throughout the door closing process can bend the glass enough to cause contact with the rear quarter glass, despite a proper window alignment with no force applied.

Updated lightweight door glass parts have been developed to address this complaint. Please see the *Door glass: cracks in the top corner* section of the Service Information for repair instructions.

Please replace the affected glass pane(s) with the updated parts (index "H"), as instructed in *WM 644019 – Removing and installing door window glass*.

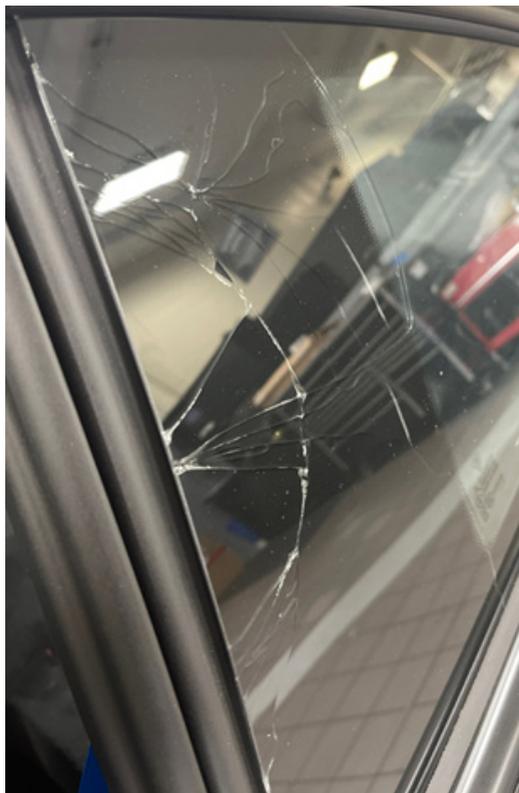
**Figure 2 - Rear quarter glass (side window pane): cracks near front edge**

There are two main causes for this condition:

- > The door glass is misaligned, which can cause contact between the door glass and the rear quarter glass, or
- > The quarter glass mounting nuts are over-torqued

This condition is possible on both the driver and passenger sides of the vehicle.

Please see the *Rear quarter glass (side window pane): cracks near front edge* section of the Service Information for repair instructions.

Please replace the affected glass pane(s) as instructed in *WM 647519 – Removing and installing side window (Coupe)*.

Please exercise additional caution when tightening the fastening nuts for the glass pane. Applying too much torque to the fastening nuts may cause the glass pane to crack.

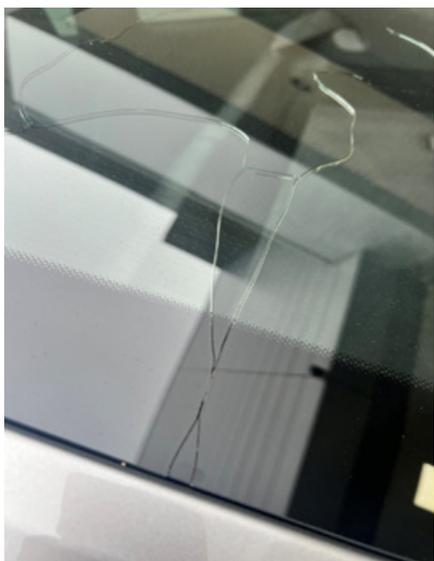
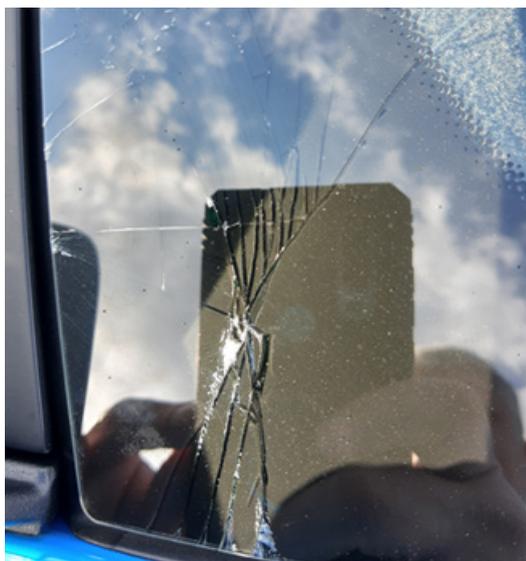
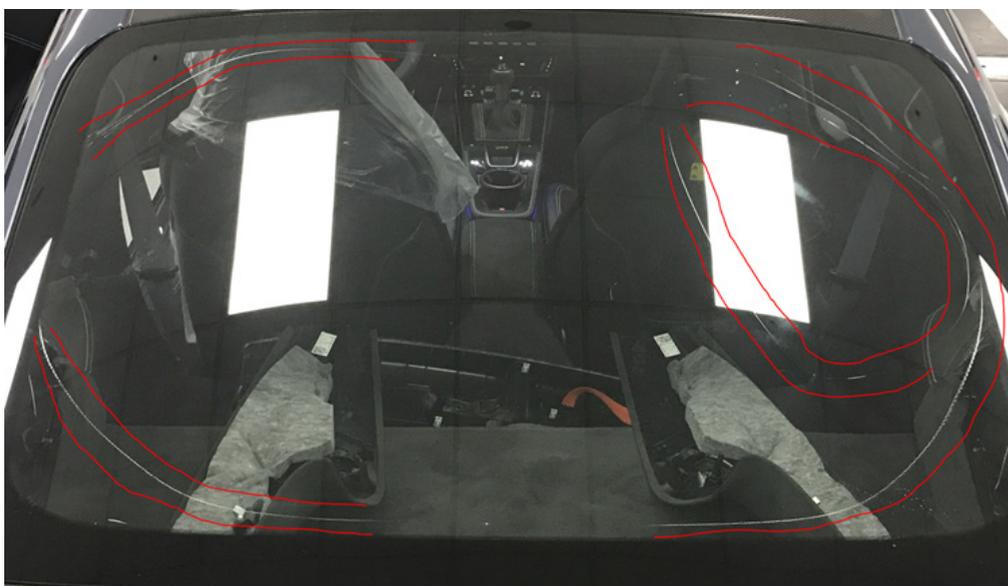
**Figure 3 - Rear window glass: various cracks**

Stress cracks in the rear window glass are currently being analyzed by Porsche. The root causes for the different kinds of stress cracks are unknown at the time of publication of this document.

Please see the *Rear window glass: various cracks* section of the Service Information for repair instructions.

Please replace the rear window glass as instructed in *WM 648619 – Removing and installing rear window*.

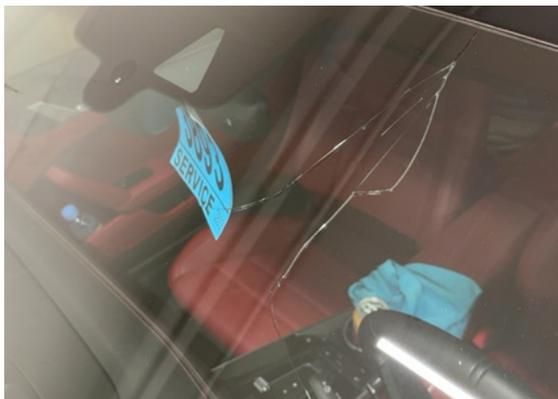
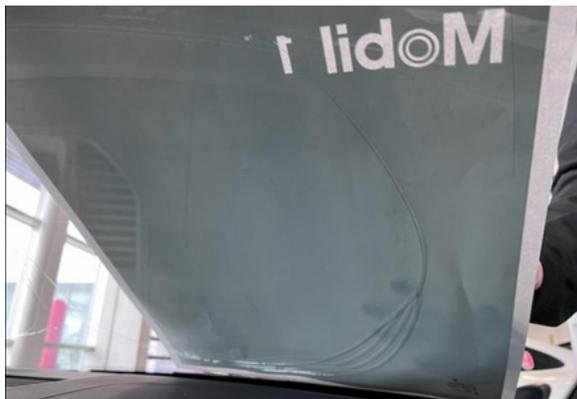
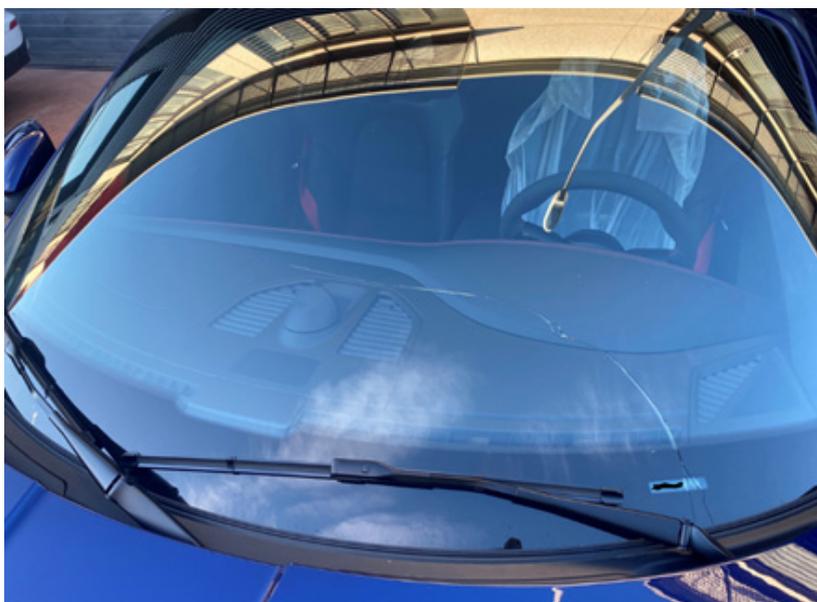
**Figure 4 - Front windshield: various cracks**

The stress cracks in the front windshield are caused by too much stress in the outer glass pane. Updated parts have been developed to address this issue.

Please see the *Front windshield: various cracks* section of the Service Information for repair instructions.

Updated parts are available since September 4, 2023.

Please replace the front windshield as instructed in *WM 641219 – Removing and installing rear windscreed*, with the latest available version in PET.
