**Surround View Camera Intermittent Operation**

Models	Model Year	Model Type	VIN Range	Vehicle-Specific Equipment
911	As of 2020 up to 2024	992	N/A	KA6

Advanced Technical Information

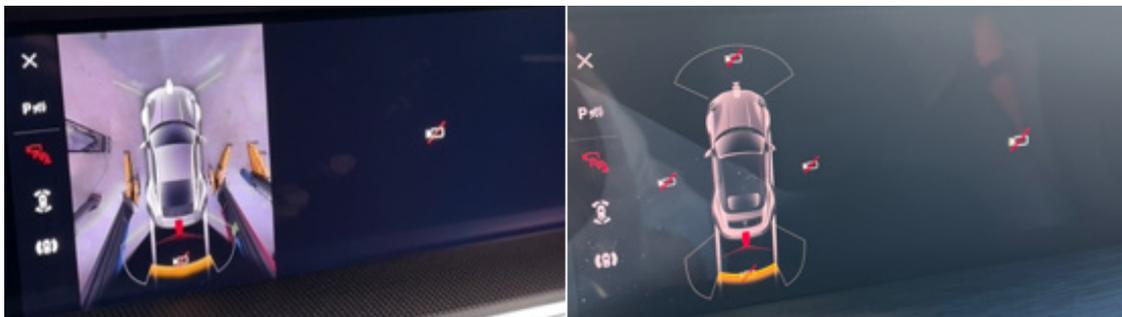
Figure 1

Customer complains of intermittent operation for one or multiple surround view cameras. Failed surround camera(s) appear blank with a crossed-out camera icon.
