GENERAL MOTORS DCS7158 URGENT - DISTRIBUTE IMMEDIATELY

Subject: A252495390 - Service Update

Oil Plug Seated Improperly

Models: 2025 Cadillac CT5-V Blackwing

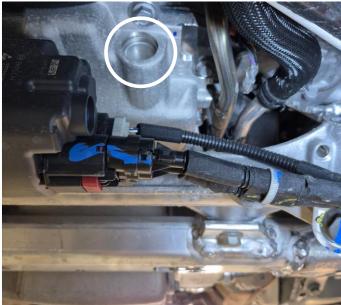
6860566

1. Remove the Front Cradle Shear Plate. Refer to Front Cradle Shear Plate Replacement (1SV) in SI.

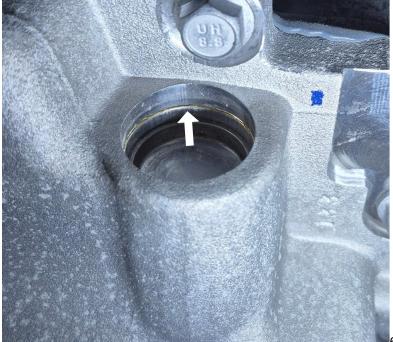
6860567

2. Locate the oil pan pickup tube plug on the front of the oil pan (driver's side) as shown.

IMPORTANT: The depth to which the plug is pressed beyond the counterbore may vary. As long as the counterbore line is visible as indicated above, no further action is required.

- 3. Inspect the oil pan pickup tube plug.
 - If the plug is pressed to a point where the counterbore line is visible (indicated by white arrow above) no further action is required. Proceed to step 6.
 - If the plug is NOT pressed deep enough to expose the counterbore line, proceed to the next step.
