# Service Bulletin

Bulletin No.: PIE0806A

**Subject:** Engineering Information - (EI Lite) (Picture Only) Rocker Moldings Experiencing Poor Fit, Loose Parts, Broken Clips and/or Warp

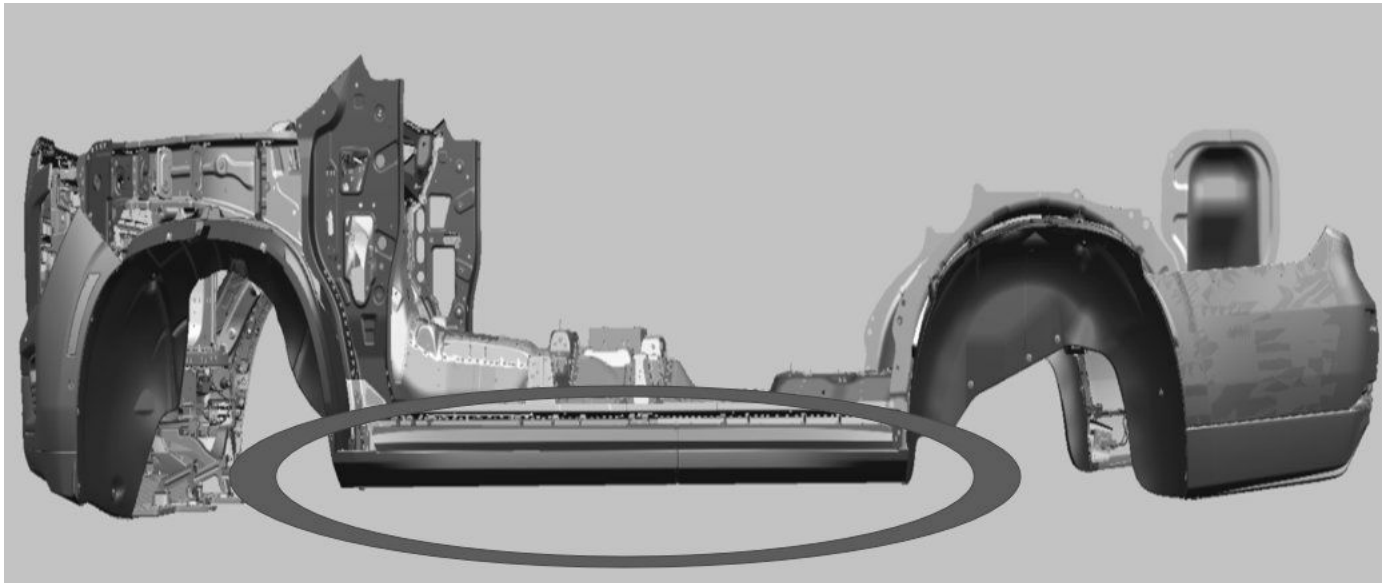
6751317

1. Take a clear picture of the entire area of the vehicle showing the location of the issue area, as shown in the picture above.

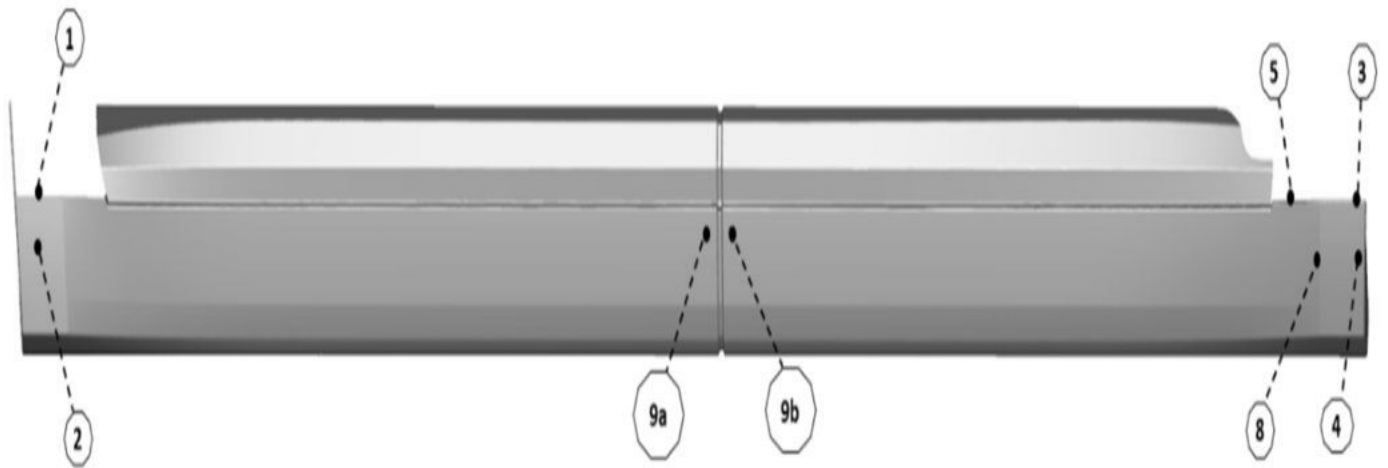
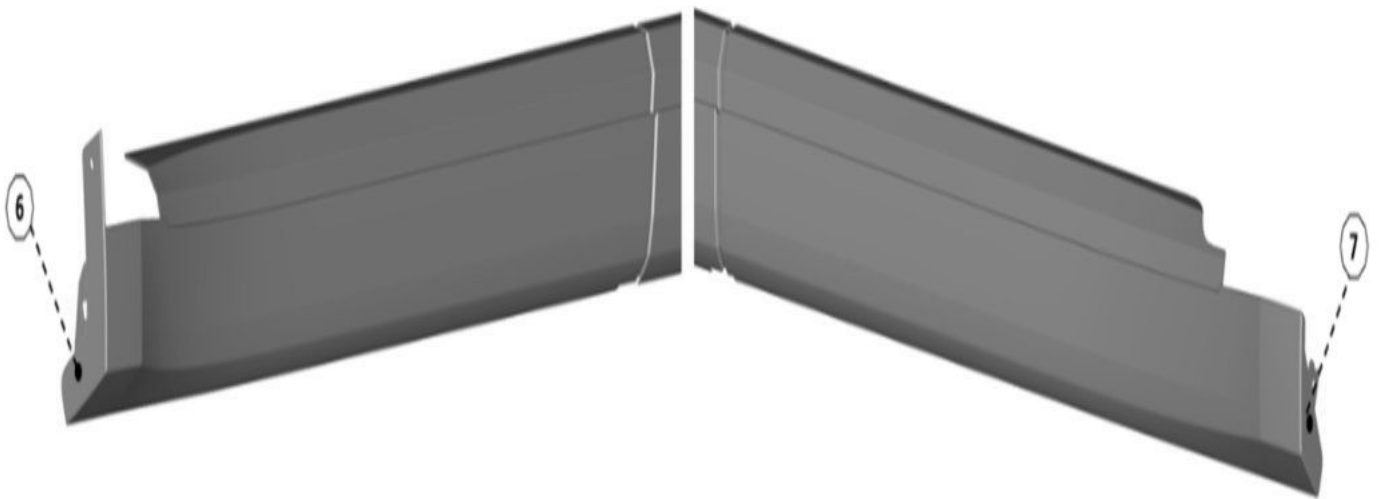
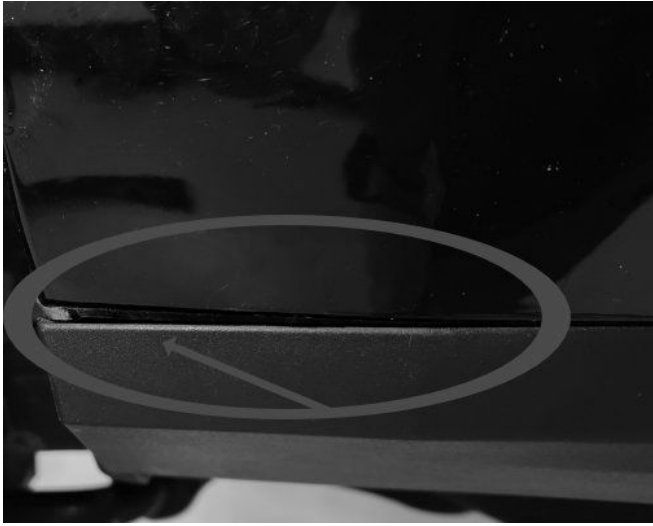
2. Take a clear close-up picture of the issue area and note the area of concern, as shown in the pictures above
