UNDER BONNET FUEL LINE REMOVAL AND INSTALLATION REQUIREMENT WHEN REPLACING SPARK PLUGS DURING SERVICE- NC10/NC11

Range Rover

- 22MY+ Range Rover
- 23MY + Range Rover Sport

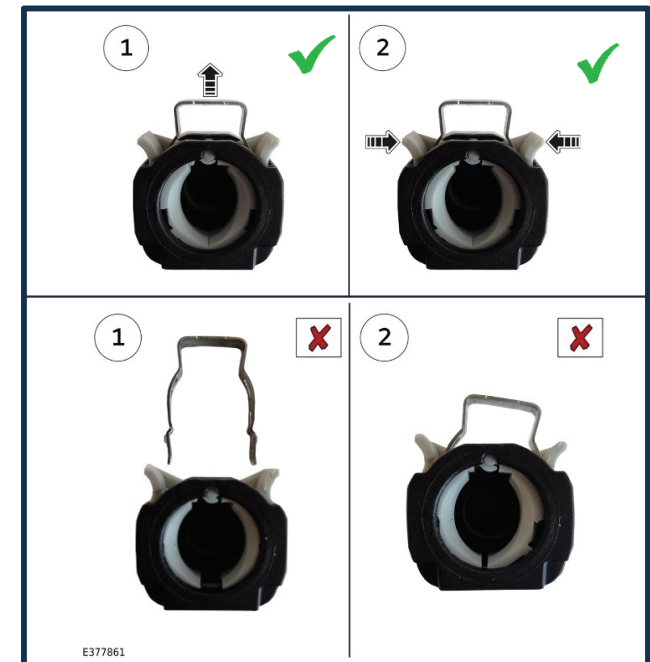
- Incorrect removal and/or installation of the LP fuel supply line may lead to damage to the fuel line connectors, requiring replacement.

- When replacing spark plugs, the service procedure requires the removal and installation of the LP fuel supply line (part number LR152523 or LR174145)
- Please follow the TOPIx Workshop Manual to make sure that the fuel line connectors are not damaged during removal and installation , section 310-01 Fuel Tanks and Lines - Removal and Installation - Fuel Supply Line.
- Note: If the fuel line connectors are damaged during removal or installation, the fuel line must be replaced.
