## Field campaign

| Topic | Software update for the rear door control modules - 00BB and 00BC - 25MY (SC24/25) |
| Brand | Bentley |
| Campaign number | ED18 |

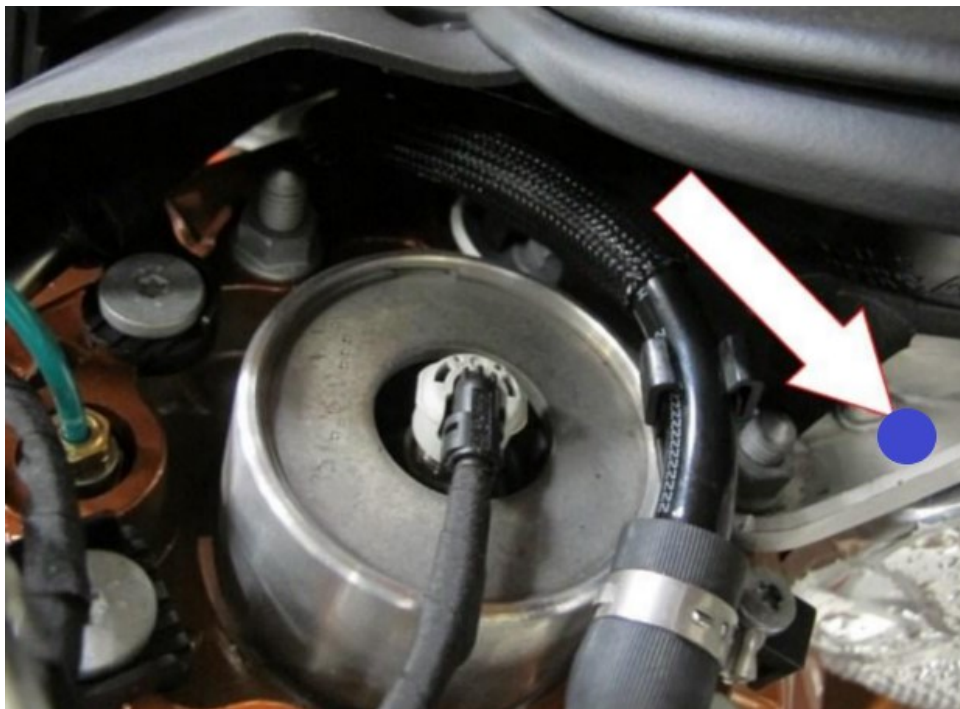
Figure 3

Blue paint completion mark on the engine partition brace

13) Referring to the Identification section - Apply a blue paint completion mark on the engine partition brace (Figure 3)
