THERMOSTAT HOUSING ENGINE COOLANT LEAK – I4/2.0L

Refer to SSM 76249/ SSM 76248

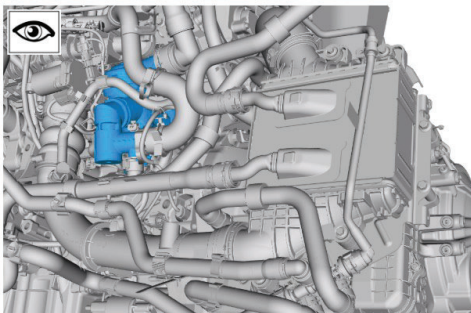
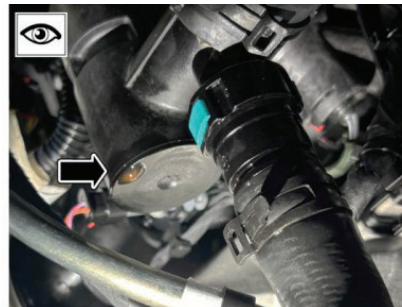
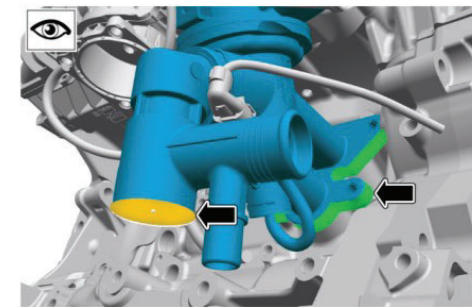
- Possible leak at thermostat housing at welded spigot cap

- If you have diagnosed an engine coolant leak at the thermostat housing, proceed to repair the vehicle
- Please raise an Electronic Product Quality Report (EPQR) and include the below information:
 - Photographs/video evidence of the thermostat housing engine coolant leak (before parts are removed from the vehicle)
 - Photographs/video evidence of the thermostat housing removed from the vehicle and any obvious defects/leak paths.
