# Technical Service Bulletin

| Topic | New Continental GT and New Continental GTC - Window drop glass operation |
| Transaction No. | 2075821/1 |
| Release date | Feb 24, 2025 |

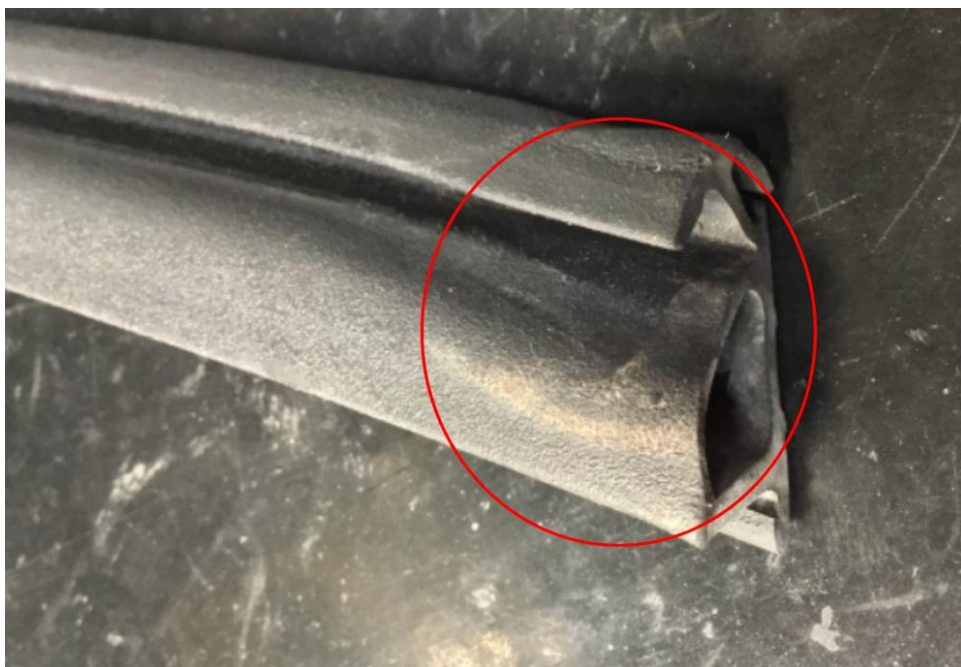
Figure 8

- Damage
- Splits
- Tears
- Misalignment
- Incorrectly fitted / located
- Drop glass seal deformation (see Figures 8 and 9 as examples)

**NOTE:** Any issues found with the window seals must be rectified before conducting the remaining steps
