# Technical Service Bulletin

<b>Topic</b>	DTC P04F000 EVAP system high pressure purge line performance DTC logged
<b>Market area</b>	China 723 Volkswagen (Anhui) Automotive CO (6723),China 796 VW Import Comp. Ltd (Vico), Beijing (6796),Korea, (South) E08 Bentley South Korea (6E08),United States E05 Bentley USA and rest America (6E05)
<b>Brand</b>	Bentley
<b>Transaction No.</b>	2058573/5
<b>Level</b>	EH
<b>Status</b>	Released for publishing
<b>Release date</b>	Feb 21, 2025

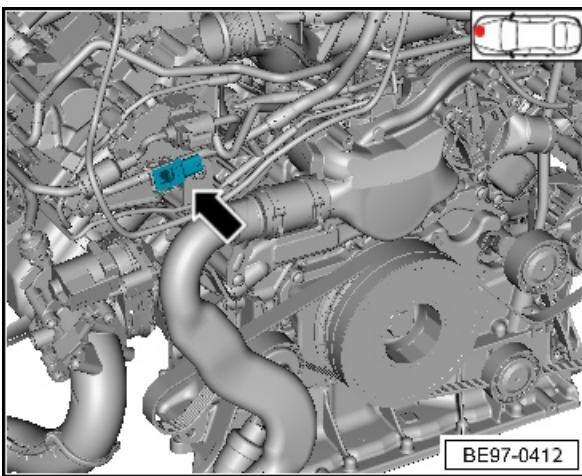
Figure 2

The DTC is related to mismatched terminal locations of the Pressure sensor for the activated charcoal filter system – G804 (Figure 2)

2) Should the terminal locations NOT be as shown in Figure 3, the terminals should be reallocated within plug as per the wiring diagram

- Refer to Repair manual Rep.Gr 20 - Tank ventilation pressure sensors - To remove and fit to gain access to the sensor connection
- Reallocate the sensor terminals as per Elsa pro wiring diagram instruction

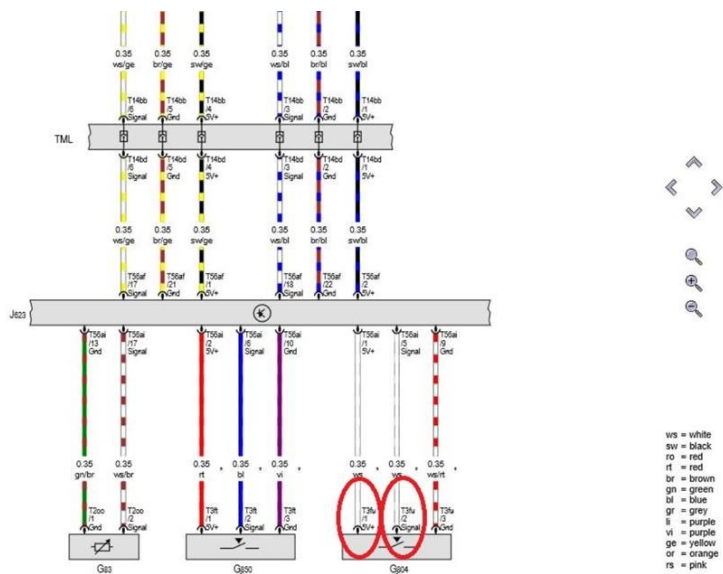
Figure 3

1) Refer to Wiring diagram 106/18 within Elsa pro (Figure 3)
