Technical Service Bulletin

Topic	Unable to run basic settings within the Adaptive suspension control unit (J775)
Market area	Australia E04 Bentley rest Asia and Australia (6E04),China 723 Volkswagen (Anhui) Automotive CO (6723),China 796 VW Import Comp. Ltd (Vico), Beijing (6796),Germany E02 Bentley rest Europe (6E02),Japan E03 Bentley Japan (6E03),Korea, (South) E08 Bentley South Korea (6E08),United Arab Emirates E06 Bentley Middle East and Africa (6E06),United Kingdom E01 Bentley UK (6E01),United States E05 Bentley USA and rest America (6E05)
Brand	Bentley
Transaction No.	2055693/5
Level	EH
Status	Released for publishing
Release date	Feb 21, 2025

Unable to run Basic setting (full process + rebound end stops) after a new adaptive air suspension control unit has been fitted or work has been conducted on the suspension system which requires the Basic setting (full process + rebound end stops) procedure performing

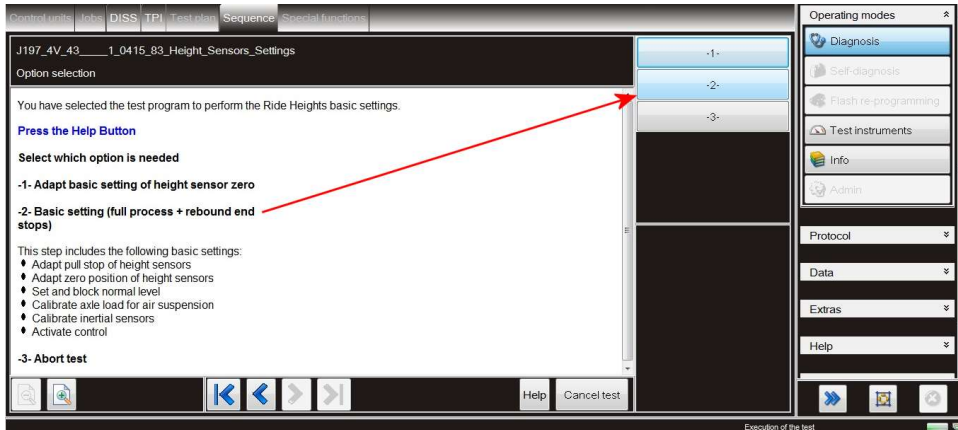
Figure 1

Referring to Figure 1, During the Basic setting (full process + rebound end stops) the routine can stop during the initial part of the procedure, in particular at the stage shown in Figure 2, which is when the vehicle is raised to allow all four wheels to hang down to their full rebound position

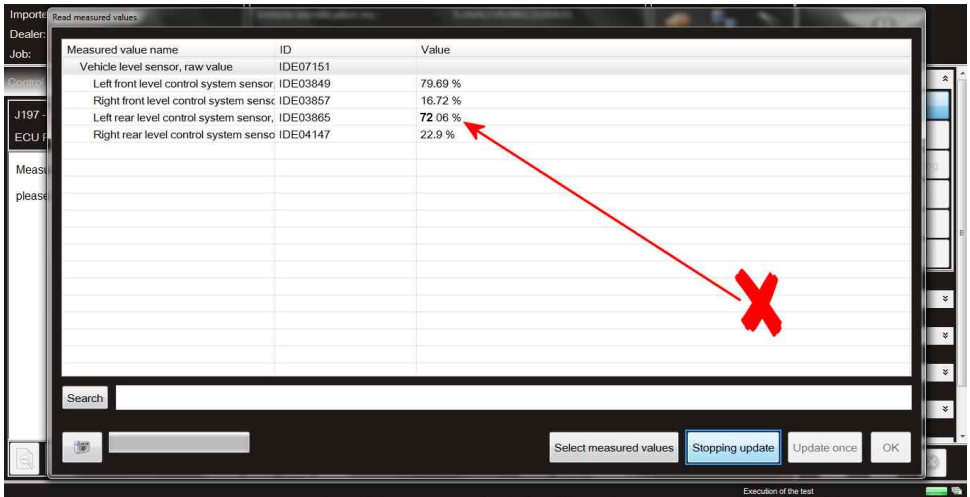
- Compare the sensor measured results in Figure 4 against the correct tolerance bands shown in Figure 5
- Within the example shown, the left hand rear level control sensor is not in tolerance as the value is 72.06%

- When IDE 07151 is located - Select - Starting update
- Monitor the measured value results for each level control sensor (Figure 4)

3) To allow the Basic setting (full process + rebound end stops) to be successfully completed the measured value results must all be within the tolerance bands shown in Figure 5

- Manually adjust the out of range level sensor by moving the sensor connecting arm whilst monitoring the values until the value falls within the specified tolerance band

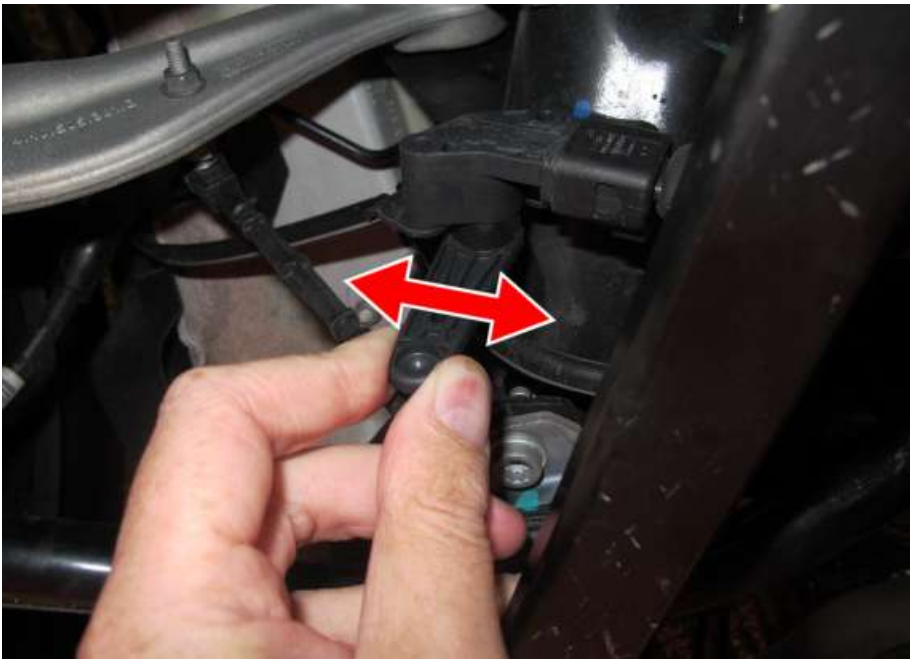
NOTE: For photographic purposes only the left hand rear sensor is shown in Figure 6

Referring to Figure 6, The correct tolerance should be achieved by moving the sensor arm (by hand within the parts natural limits of movement) in the required direction until the tolerance band is within specification NOTE: The tolerance can be achieved by using the recommended method

⚠ DO NOT ATTEMPT TO ADJUST THE TOLERANCE BAND OF THE LEVEL SENSORS BY PRYING, BENDING OR MANIPULATING THE SENSOR RODS BY THE USE OF FORCE

- Once the required tolerance band criteria is met carry out the Basic setting (full process + rebound end stops) until completion
