GROUP	MODEL
ELE	2019-2022MY Niro EV (DE EV)
NUMBER	DATE
270 (Rev 3, 03/03/2025)	April 2023

TECHNICAL SERVICE BULLETIN

SERVICE ACTION: INVERTER COOLANT/DEBRIS

SUBJECT: **FLUSHING/REPLACEMENT FOR CLUSTER MESSAGE
"REFILL INVERTER COOLANT" (SA512)**

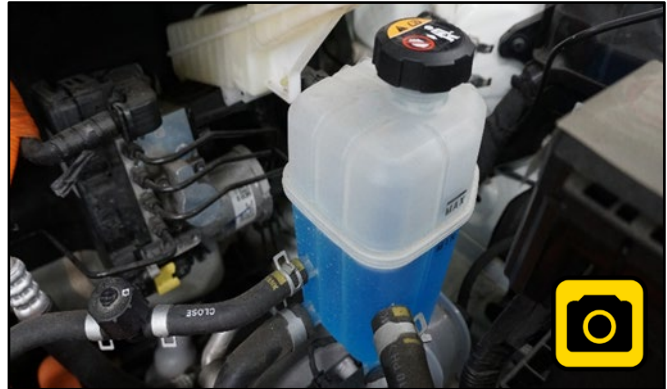
1. **If the vehicle has General Type Coolant (green), this service action does not apply.**

If the vehicle has Low-Conductivity Coolant (BSC-1) (blue), continue to step 2 to replace it with (BSC-2) to complete this service action.

Submit a KVID photo of the green coolant filled reservoir and use Op Code 230020R2.

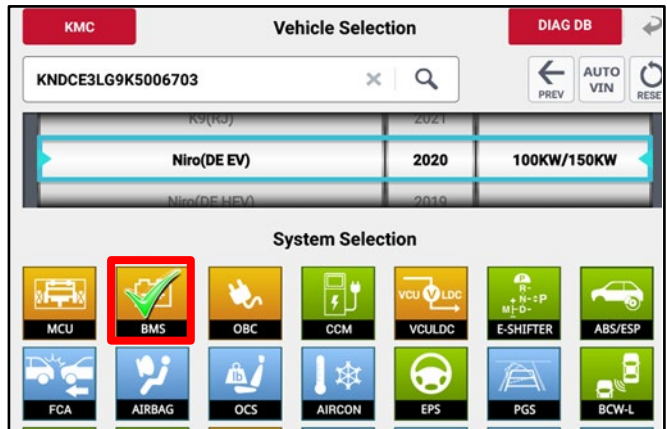
4. Ensure the 'Battery BTMS Valve Control Mode' is in 'Combined Mode'.

If 'Battery BTMS Valve Control Mode' is in 'Separated Mode', turn the ignition 'ON' and 'OFF' to change to 'Combined Mode'.

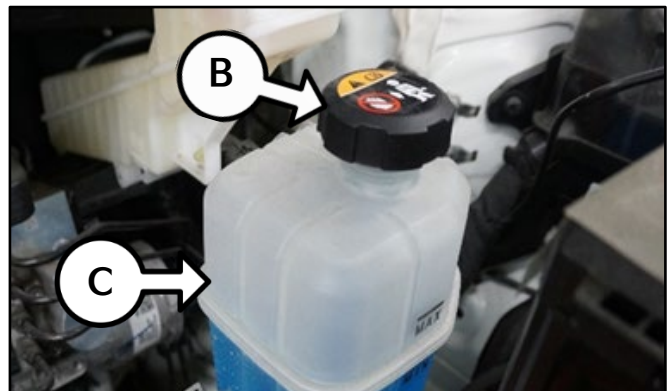
Coolant reservoir cap has reverse threads.

7. Remove the coolant reservoir (C) cap (B).
