# Technical Service Bulletin

<b>Topic</b>	Bentayga - PDC system not working or PDC system false detection
<b>Market area</b>	Australia E04 Bentley rest Asia and Australia (6E04),China 723 Volkswagen (Anhui) Automotive CO (6723),China 796 VW Import Comp. Ltd (Vico), Beijing (6796),Germany E02 Bentley rest Europe (6E02),Japan E03 Bentley Japan (6E03),Korea, (South) E08 Bentley South Korea (6E08),United Arab Emirates E06 Bentley Middle East and Africa (6E06),United Kingdom E01 Bentley UK (6E01),United States E05 Bentley USA and rest America (6E05)
<b>Brand</b>	Bentley
<b>Transaction No.</b>	2059392/5
<b>Level</b>	EH
<b>Status</b>	Released for publishing
<b>Release date</b>	Feb 21, 2025

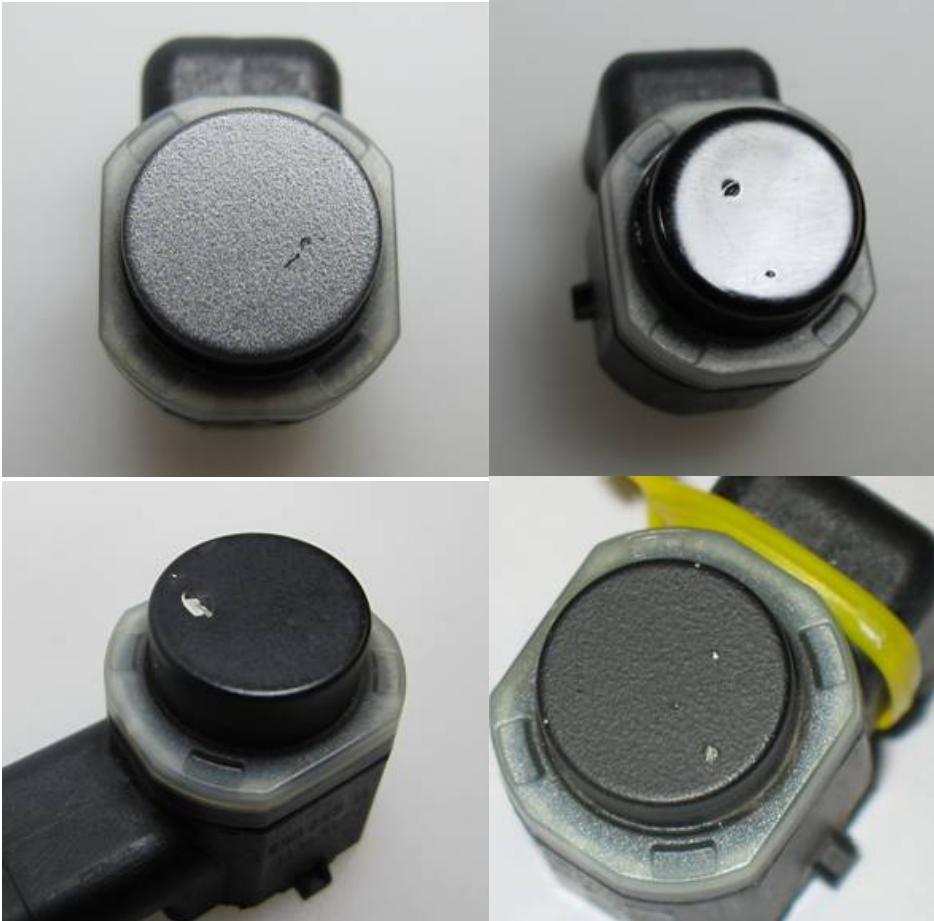
- Dirt, ice, foreign bodies, foil stuck on
- Check any damage on the bumper, air inlet grille and underbody which may indicate a parking accident
- Mechanical damage (stone chips, scratches)

**IMPORTANT: With the following examples stone chips led to the failure of the sensor:**

**Stone chips and scratches are not complaints in the sense of warranty. Therefore dirty sensors should be cleaned and not replaced**

**Any sensors which are replaced for stone chips, scratches or any other type of damage will not be approved for warranty payment**

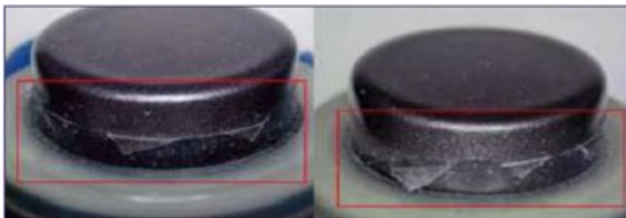
**Paint overspray**

9. when painting sensors ensure to paint within area specifications, removable layers of paint on the membrane can lead to false signals
