Technical Service Bulletin

Topic	Road wheel inspection procedure
Market area	Australia E04 Bentley rest Asia and Australia (6E04),China 723 Volkswagen (Anhui) Automotive CO (6723),China 796 VW Import Comp. Ltd (Vico), Beijing (6796),Germany E02 Bentley rest Europe (6E02),Japan E03 Bentley Japan (6E03),Korea, (South) E08 Bentley South Korea (6E08),United Arab Emirates E06 Bentley Middle East and Africa (6E06),United Kingdom E01 Bentley UK (6E01),United States E05 Bentley USA and rest America (6E05)
Brand	Bentley
Transaction No.	2063017/4
Level	EH
Status	Released for publishing
Release date	Feb 21, 2025

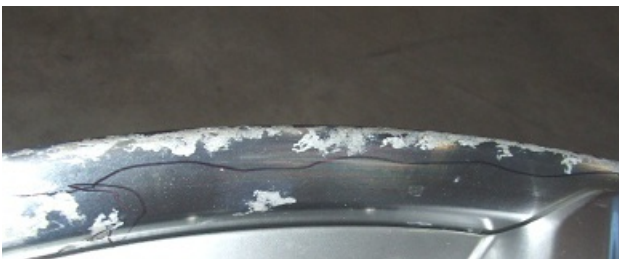
Filiform corrosion in the middle of the rim initially caused by impact damage to the lacquer coat, such as stone chips

- Both Figure 1 and Figure 2 do not show a manufacturing defect

and are not claimable under warranty

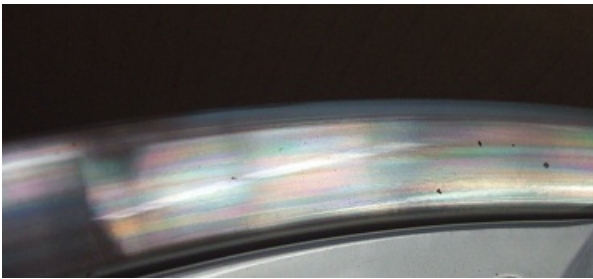
Figure 3

- Wheels that have been re-furbished are more susceptible to filiform corrosion because the surface finish has been tampered with

The original wheel finish has a prismatic effect (Figure 3)

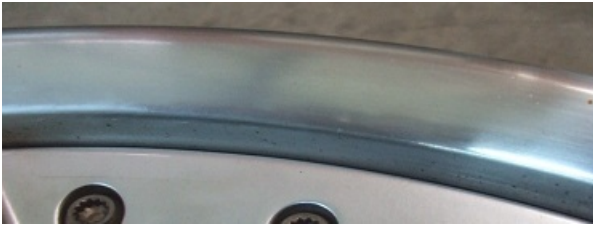
Figure 4 shows the tell tale sign of re-work as the finish is duller and no prismatic effect is visible. Re-worked wheels that show signs of corrosion or defects cannot be claimed under warranty

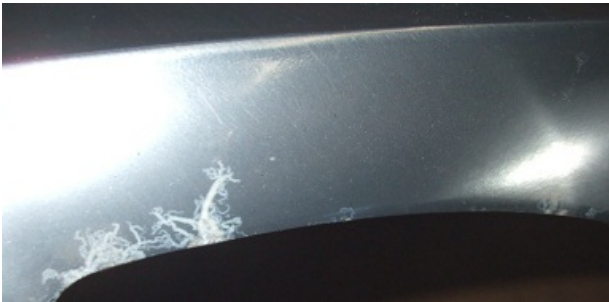
Figure 5

Filiform corrosion coming from sharp edge on the spoke. In this area it is difficult for the supplier to get the specified lacquer coverage

- Both of these could be classed as a manufacturing defect and are claimable under warranty

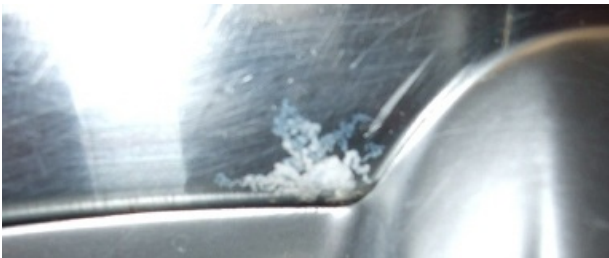
Figure 6

Filiform corrosion coming from behind the inner wheel piece is highly unlikely to be caused by impact damage. It is therefore more likely due to low lacquer coverage

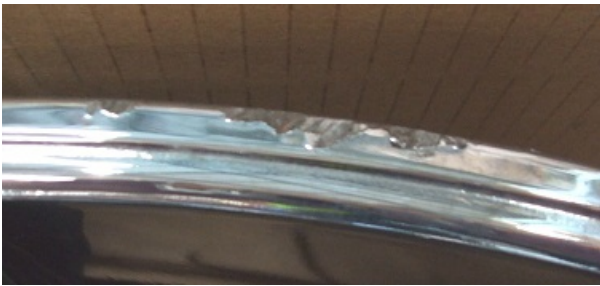
Marks on the rim due to curbing

- Both Figure 7 and Figure 8 do not show a manufacturing defect and are not claimable under warranty

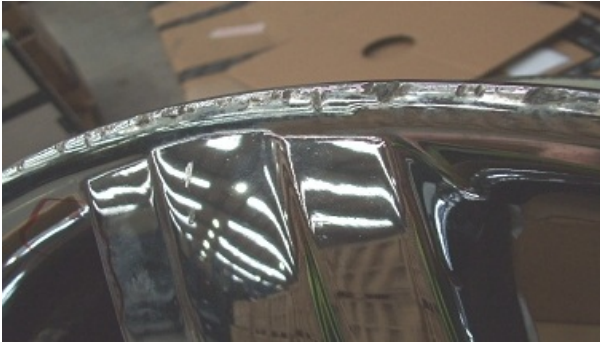
Figure 8

Damage to the rim due to curbing but also damage to the spoke caused by impact damage, such as stone chips

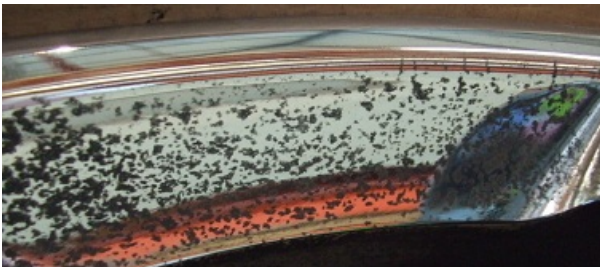
Figure 9

- When cleaning chrome wheels, they have to be wiped down and not just sprayed with water as there is still a film of dirt that can remain on the wheels
- There are a number of variables that contribute to pitted wheels, such as brake dust, salt, dust/dirt, ice/snow melting chemicals
- Chrome wheels should never be washed while still hot from driving as they could warp or pit

- Pitting is not a manufacturing defect and cannot be claimed under Warranty (Figure 9)

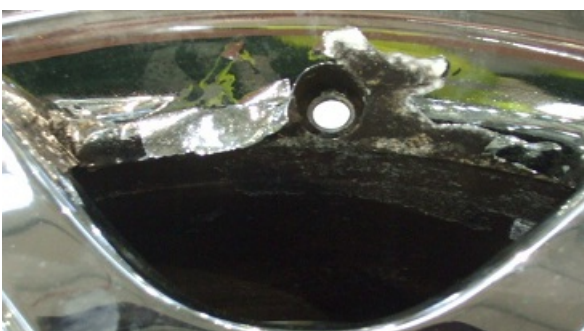
Figure 10

- Aluminium alloy wheels are one of the most difficult substrates to reliably plate
- Peeling almost always comes from improper preparation and plating, not environmental exposure (Figure 10)

- Peeling is classed as a manufacturing defect and is claimable under warranty
