Technical Service Bulletin

| Topic | Tyre tread/sidewall crack(s) |
| Brand | Bentley |
| Transaction No. | 2063651/4 |

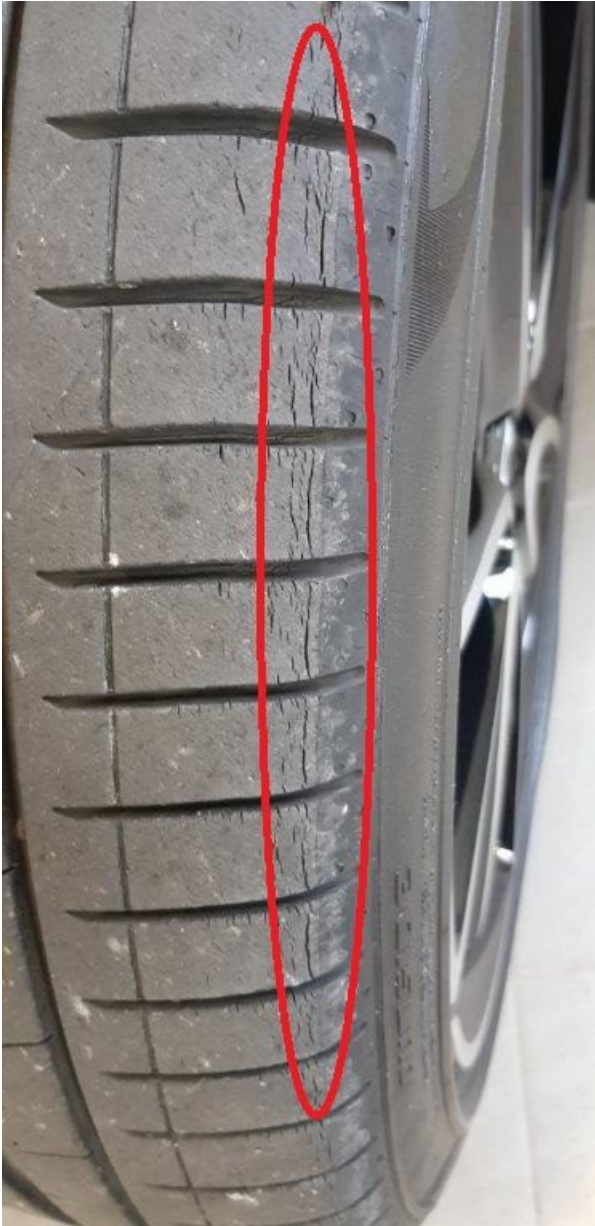
Figure 1

Cracks evident in the sidewall and/or tread pattern (See the examples in Figures 1 and 2 showing cracks within the tread pattern)

The issue is mainly evident on vehicles with very low usage

This is a result of the tyre compound hardening due to the following:

- Tyre age
- Tyre pressure not adjusted to specification
- Low mileage/vehicle usage
- Vehicle storage conditions

When cars are found to be at low mileage or have not been used regularly for an extended period of time, the oils and compound of the rubber can dry up due to a lack of repeated compression, this can lead to compound separation.

- Tyres will require replacement if cracks and/or signs of wear are found on or around the tread pattern (Point A)
- In the event that cracks and/or signs of wear are found on the sidewall (Point B) or at (Point A and B) the operative **MUST** raise a technical DISS query ensuring clear photographs and information detailing customer usage profile are attached to the DISS query

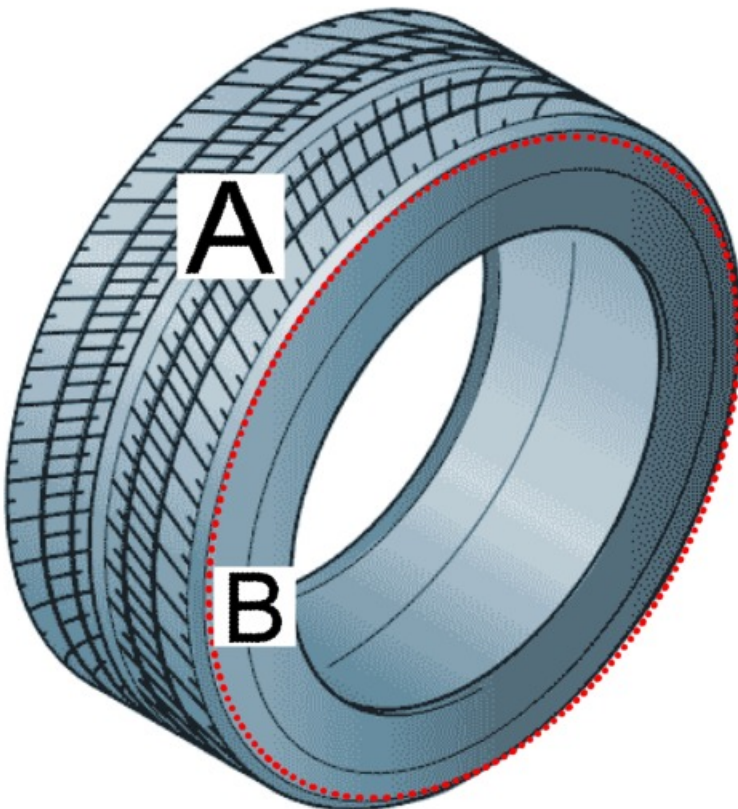
Referring to Figure 3
