# Technical Service Bulletin

<b>Topic</b>	DTC B17B801 and/or B17B804 - evident within address 0019 and/or DTC U112300 evident in 00A5
<b>Market area</b>	Bentley: worldwide (2WBE),China 723 Volkswagen (Anhui) Automotive CO (6723),China 796 VW Import Comp. Ltd (Vico), Beijing (6796)
<b>Brand</b>	Bentley
<b>Transaction No.</b>	2063855/11
<b>Level</b>	EH
<b>Status</b>	Released for publishing
<b>Release date</b>	Feb 26, 2025

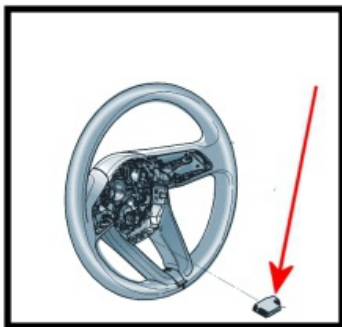
- Lane Assist and / or Traffic Assist are not functional
- DTC - B17B801 - Steering Wheel Touch Recognition Control Module evident within address 0019

- 1) Referring to Rep.Gr 69 - Remove the driver's air bag
- 2) Referring to Figure 1 - Replace the Steering Wheel Contact Detection control unit (J1158)

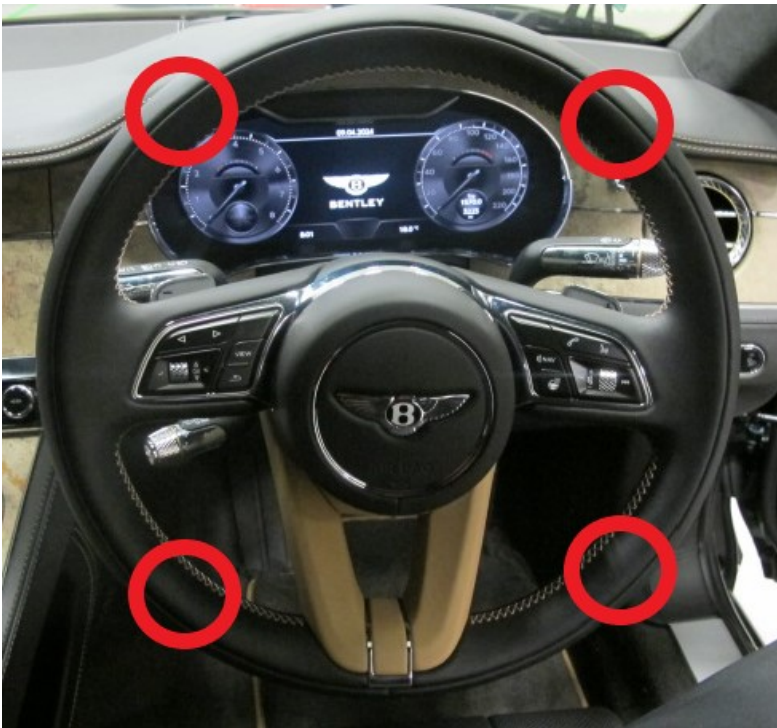
- Monitor the Sensor 2 and Sensor 3 values whilst holding the steering wheel at the points shown - **The expected values are between 40 and 60 and No malfunction Detected**

Sensor 2 and sensor 3 should recognise contact with the steering wheel and will show the values changing if the system is working to specification

- Place hands (light grip) on the steering wheel at the various points as shown in Figure 3
