Technical Service Bulletin

Topic	Creaking/squeak noise from the front suspension (upper inner lever bushes)
Market area	Australia E04 Bentley rest Asia and Australia (6E04),China 723 Volkswagen (Anhui) Automotive CO (6723),China 796 VW Import Comp. Ltd (Vico), Beijing (6796),Germany E02 Bentley rest Europe (6E02),Japan E03 Bentley Japan (6E03),Korea, (South) E08 Bentley South Korea (6E08),United Arab Emirates E06 Bentley Middle East and Africa (6E06),United Kingdom E01 Bentley UK (6E01),United States E05 Bentley USA and rest America (6E05)
Brand	Bentley
Transaction No.	2064779/5
Level	EH
Status	Released for publishing
Release date	Feb 21, 2025

Bentayga series

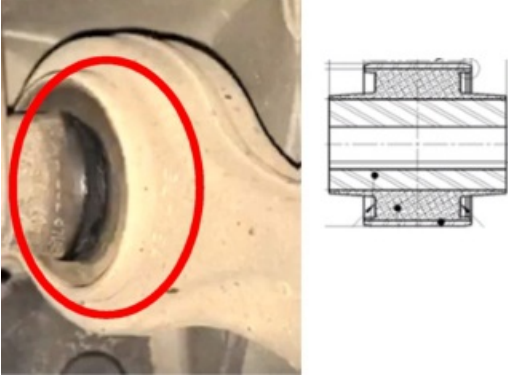
Figure 1

Defective upper inner lever bush (Figure 1)

The noise present in the sound file is caused by defective upper inner lever bush/bushes, the noise can appear in the following possible scenario

- When the vehicle is moved with steering input over uneven surfaces (for e.g. a ramp or speed bump)

1) Replace the left hand front (x2) and right hand front (x2) upper inner lever bushes - Refer to Repair manual Rep.Gr.40 front suspension, upper lever bush/bushes - to remove and fit
