Technical Service Bulletin

Topic	V8 Kovomo - Engine MIL light on - DTC ' P04F000: EVAP system high pressure purge line performance' evident
Market area	Australia E04 Bentley rest Asia and Australia (6E04),China 723 Volkswagen (Anhui) Automotive CO (6723),China 796 VW Import Comp. Ltd (Vico), Beijing (6796),Germany E02 Bentley rest Europe (6E02),Japan E03 Bentley Japan (6E03),Korea, (South) E08 Bentley South Korea (6E08),United Arab Emirates E06 Bentley Middle East and Africa (6E06),United Kingdom E01 Bentley UK (6E01),United States E05 Bentley USA and rest America (6E05)
Brand	Bentley
Transaction No.	2065148/5
Level	EH
Status	Released for publishing
Release date	Feb 21, 2025

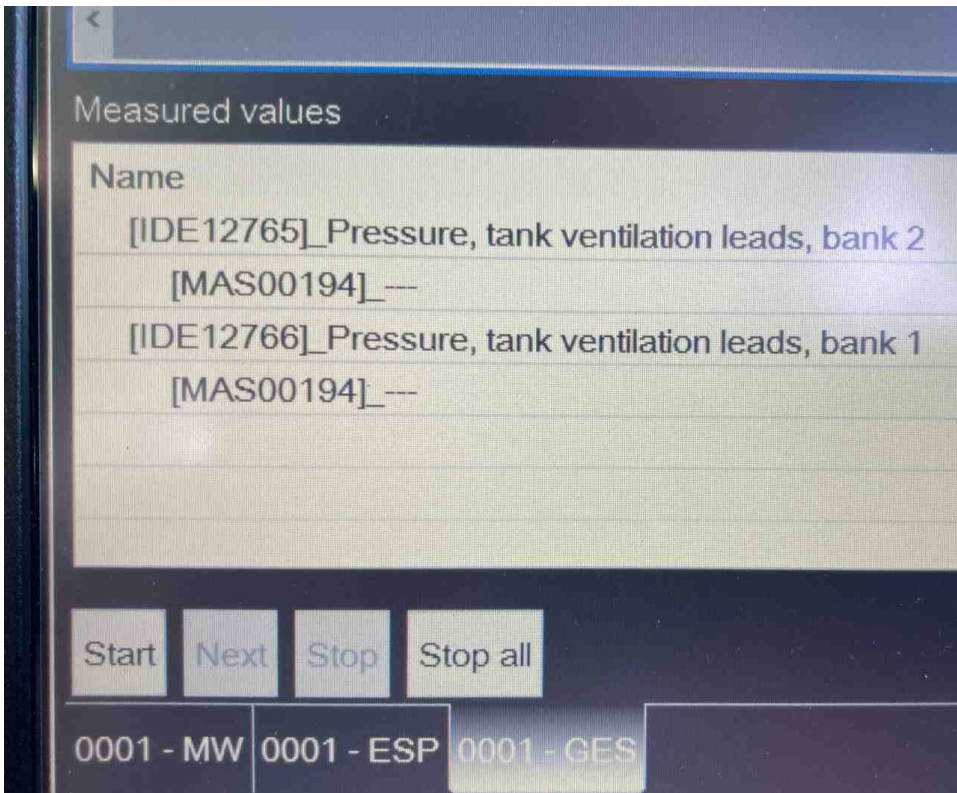
Figure 1

Referring to Figure 1:

IDE12765 (When monitored) fluctuates from the static value found (Ignition on/Engine Off)

With/without purge activation

However

IDE12766 (When monitored) DOES NOT fluctuate from the static value found (Ignition on/Engine Off)

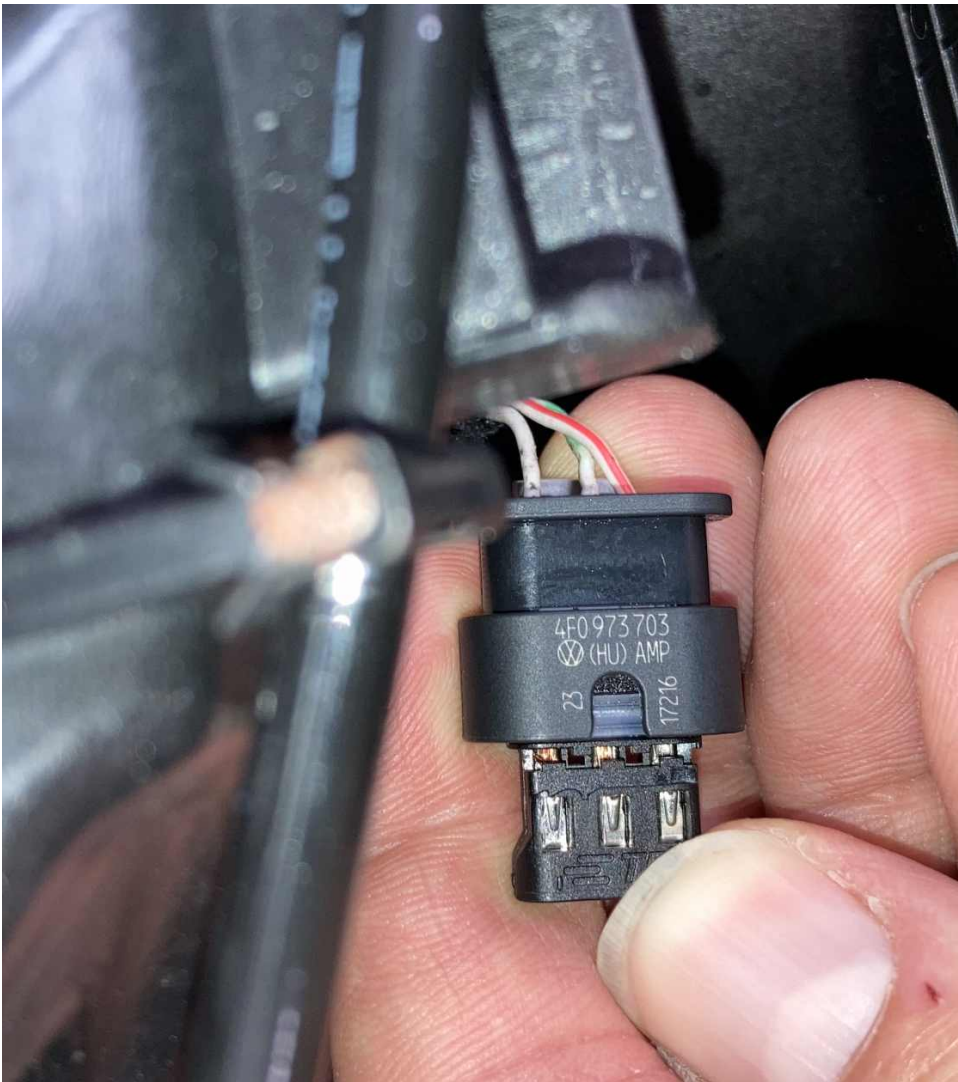
TIP: As both wires are white, the green line which can be seen on the central white wire was applied to aid the operative when swapping the PIN's to the correct locations

2) Referring to Figure 3 and the attached PDF instructions - De-pin/Remove PIN's 1 and 2 from connector T3dd

3) Install PIN 2 into PIN 1

4) Install PIN 1 into PIN 2

5) Conduct a wiring integrity check from T3dd (PIN's 1 and 2) - To Connector T56aj (PIN's 1 and 5)
