Technical Service Bulletin

Topic	Squeaking/creaking noises from the front axle and/or leaks at the lower ball joint/s
Market area	Australia E04 Bentley rest Asia and Australia (6E04),China 723 Volkswagen (Anhui) Automotive CO (6723),China 796 VW Import Comp. Ltd (Vico), Beijing (6796),Germany E02 Bentley rest Europe (6E02),Japan E03 Bentley Japan (6E03),Korea, (South) E08 Bentley South Korea (6E08),United Arab Emirates E06 Bentley Middle East and Africa (6E06),United Kingdom E01 Bentley UK (6E01),United States E05 Bentley USA and rest America (6E05)
Brand	Bentley
Transaction No.	2065197/4
Level	EH
Status	Released for publishing
Release date	Feb 21, 2025

Bentayga Series

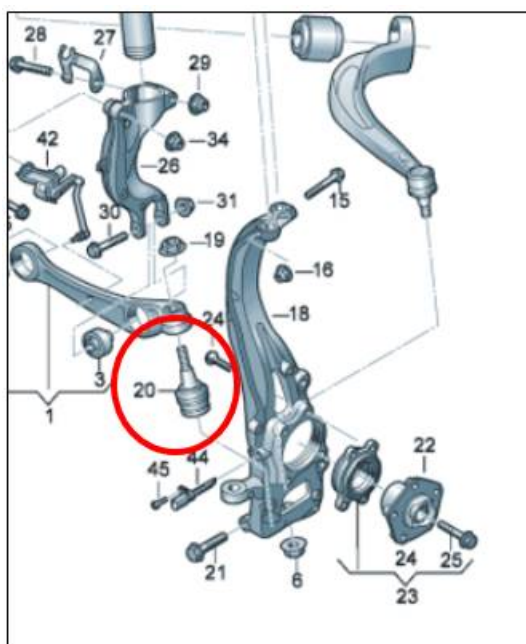
Figure 1

The noises can be assigned to the lower ball joint on the left and/or right side (Figure 1 - item 20).

Leak at the boot of the lower ball joint on the left and/or right side (Figure 1- item 20) is visible however the boot is undamaged.

NOTE: If the boot is damaged the lower ball joint must be replaced however warranty payments will not be permitted in this scenario

1) Referring to Rep.Gr 20 - Replace the left and/or right side lower ball joint

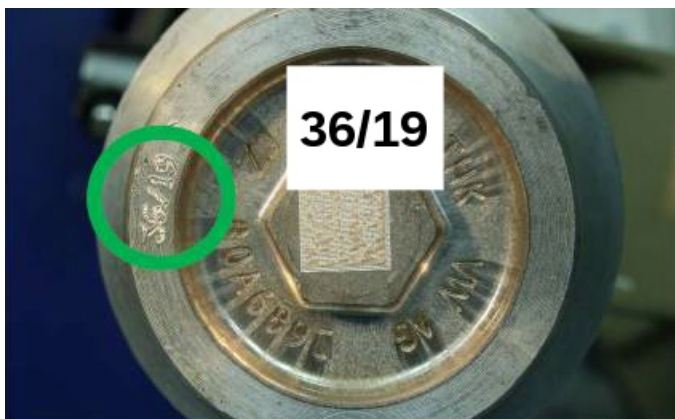
Make sure that the production date of the new ball joint is 36/19 or later (see date code example circled in Figure 2 - Week 36 of 2019).
