Technical Service Bulletin

| Topic | DTC P0B2500 logged within address 0021 (Battery Energy Control Module 2) - Dynamic ride system warning visible |
| Transaction No. | 2068946/9 |

Bentayga Series/New Continental GT/C and New Flying Spur

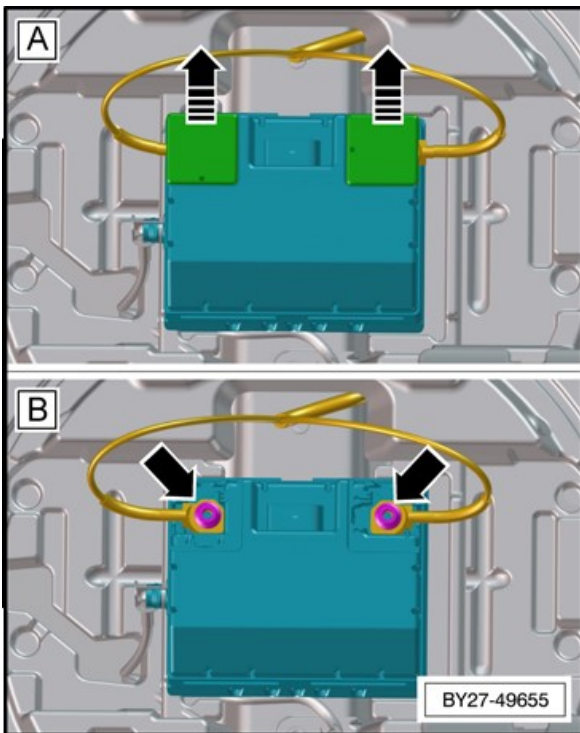
Figure 1

Possible internal fault with the super capacitor

- 1) Referring to Rep.Gr 27 - Deactivate the 48 volt system - Refer to 48 volt system - To activate and deactivate
- 2) Referring to Rep.Gr 27 - Check the security of the super capacitor positive and negative terminals (Figure 1) as follows:
 - Remove the caps (A) from the terminals
 - Check the security of the positive and negative terminals (B) are as described within Rep.Gr 27
 - In the event that one or both terminals were not tightened to the correct torque as Rep.Gr 27, the operative must tighten the terminal(s) to the correct torque as detailed within Rep.Gr 27 - Super capacitor

In the event one or both terminals required tightening to the correct torque (found to be not initially secure) the operative must feedback the findings via DISS
