Technical Service Bulletin

Topic	Right and/or left hand front rearmost lower suspension lever inner hydraulic mount replacement guidelines
Market area	Australia E04 Bentley rest Asia and Australia (6E04),China 723 Volkswagen (Anhui) Automotive CO (6723),China 796 VW Import Comp. Ltd (Vico), Beijing (6796),Germany E02 Bentley rest Europe (6E02),Japan E03 Bentley Japan (6E03),Korea, (South) E08 Bentley South Korea (6E08),United Arab Emirates E06 Bentley Middle East and Africa (6E06),United Kingdom E01 Bentley UK (6E01),United States E05 Bentley USA and rest America (6E05)
Brand	Bentley
Transaction No.	2069493/3
Level	EH
Status	Released for publishing
Release date	Feb 21, 2025

Bentayga series

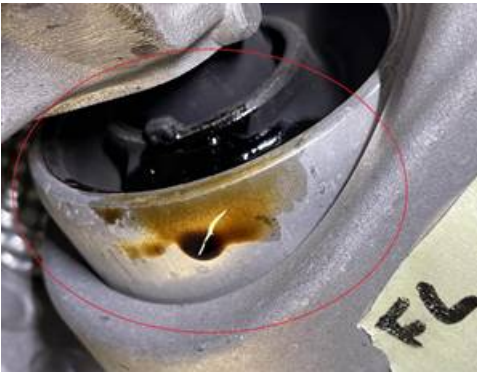
Figure 1

- If a leak is identified by the customer (Figure 1) - Replace the right and/or left hand front rearmost lower suspension lever inner hydraulic mounts as per all instructions within Rep.Gr 40

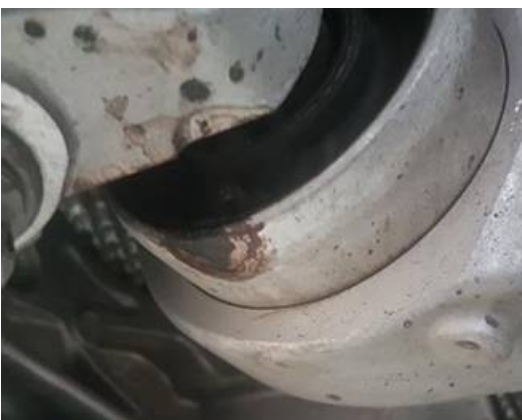
Figure 2

A dry oil stain mark (Figure 2) is evident on the right and/or left hand front rearmost lower suspension lever inner hydraulic mounts

Do not replace the hydraulic mounts

In the event a leak is spotted at service and no complaint of noise is received the operative should clean the affected area using a suitable cleaning agent do not replace the hydraulic mount in this scenario
