Technical Service Bulletin

Topic	V8 Kovomo - DTC - P025C00: Fuel Pump Module Control Circuit Low logged in 0001
Market area	Australia E04 Bentley rest Asia and Australia (6E04),China 796 VW Import Comp. Ltd (Vico), Beijing (6796),Germany E02 Bentley rest Europe (6E02),Japan E03 Bentley Japan (6E03),Korea, (South) E08 Bentley South Korea (6E08),United Arab Emirates E06 Bentley Middle East and Africa (6E06),United Kingdom E01 Bentley UK (6E01),United States E05 Bentley USA and rest America (6E05)
Brand	Bentley
Transaction No.	2071674/3
Level	EH
Status	Released for publishing
Release date	Feb 21, 2025

New Continental GT/C-New Flying Spur-Bentayga-V8 Kovomo

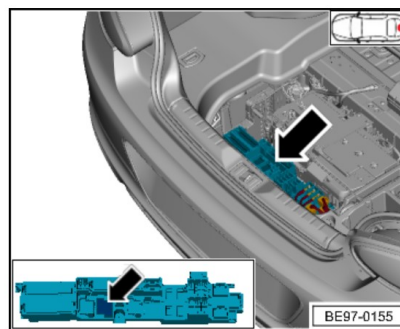
Figure 1

1) Referring to Figures 1 and 2 - Locate (J17) fuel pump relay

- Fuel pump relay -J17-

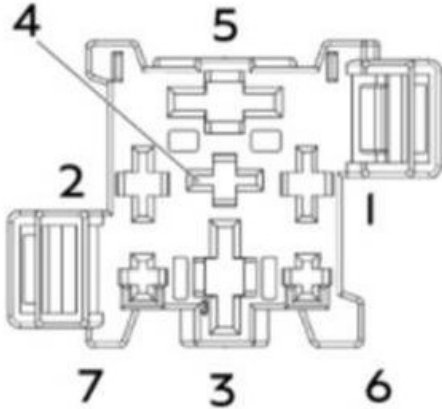
2) Referring to Figure 3 - Once removed conduct a visual check of all carrier terminals, check for the following:

- Loose terminals within the carrier
- Terminals which have spread (poor connection)
- Terminals which are damaged (poor connection)

4) Referring to Rep.Gr 97 - Wiring harness repairs - Renew the applicable terminals using the VAS 1978B wiring repair kit
