# Technical Service Bulletin

<b>Topic</b>	Steering rack diagnosed as faulty (Requires replacement) - Guidelines prior to replacing the steering rack
<b>Market area</b>	Australia E04 Bentley rest Asia and Australia (6E04),China 796 VW Import Comp. Ltd (Vico), Beijing (6796),Germany E02 Bentley rest Europe (6E02),Japan E03 Bentley Japan (6E03),Korea, (South) E08 Bentley South Korea (6E08),United Arab Emirates E06 Bentley Middle East and Africa (6E06),United Kingdom E01 Bentley UK (6E01),United States E05 Bentley USA and rest America (6E05)
<b>Brand</b>	Bentley
<b>Transaction No.</b>	2072029/2
<b>Level</b>	EH
<b>Status</b>	Released for publishing
<b>Release date</b>	Feb 21, 2025

Steering rack diagnosed as faulty (requires replacement)

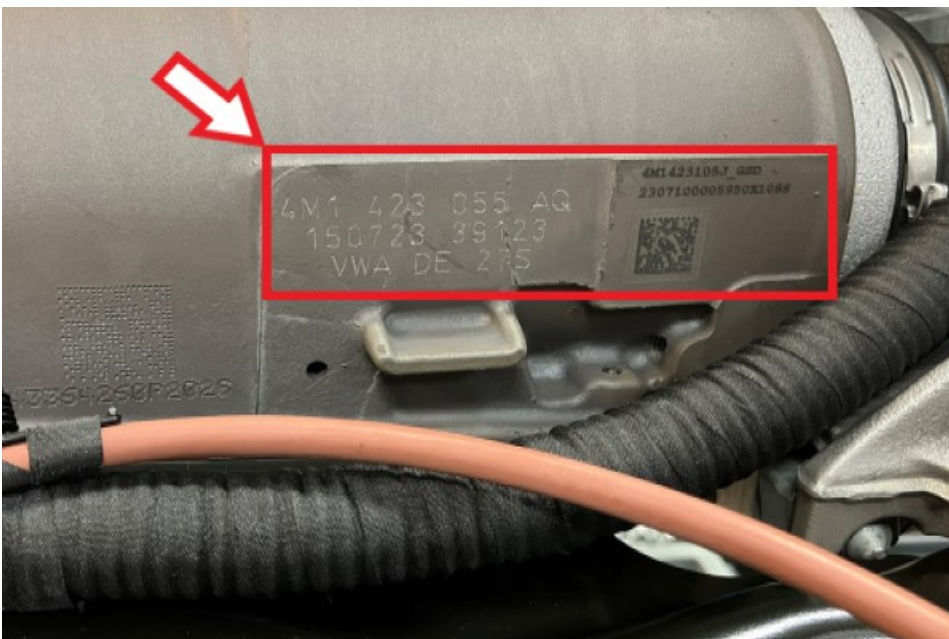
Figure 1

- Clear description of the issue for example - Noisy steering rack
- Clear video of the issue
- Clear photograph of the steering rack serial numbers (Figure 1)

2) Once the required information has been attached to a technical DISS query, the operative should wait for permission before replacing the steering rack. Once permission has been granted via DISS the steering rack can be replaced - Refer to Rep. Gr 48 Steering rack and power steering control unit (J500)
