# Technical Service Bulletin

<b>Topic</b>	Squeaking noise from the footwell whilst steering / manoeuvring at low speed
<b>Market area</b>	Australia E04 Bentley rest Asia and Australia (6E04),China 796 VW Import Comp. Ltd (Vico), Beijing (6796),Germany E02 Bentley rest Europe (6E02),Japan E03 Bentley Japan (6E03),Korea, (South) E08 Bentley South Korea (6E08),United Arab Emirates E06 Bentley Middle East and Africa (6E06),United Kingdom E01 Bentley UK (6E01),United States E05 Bentley USA and rest America (6E05)
<b>Brand</b>	Bentley
<b>Transaction No.</b>	2073002/2
<b>Level</b>	EH
<b>Status</b>	Released for publishing
<b>Release date</b>	Feb 21, 2025

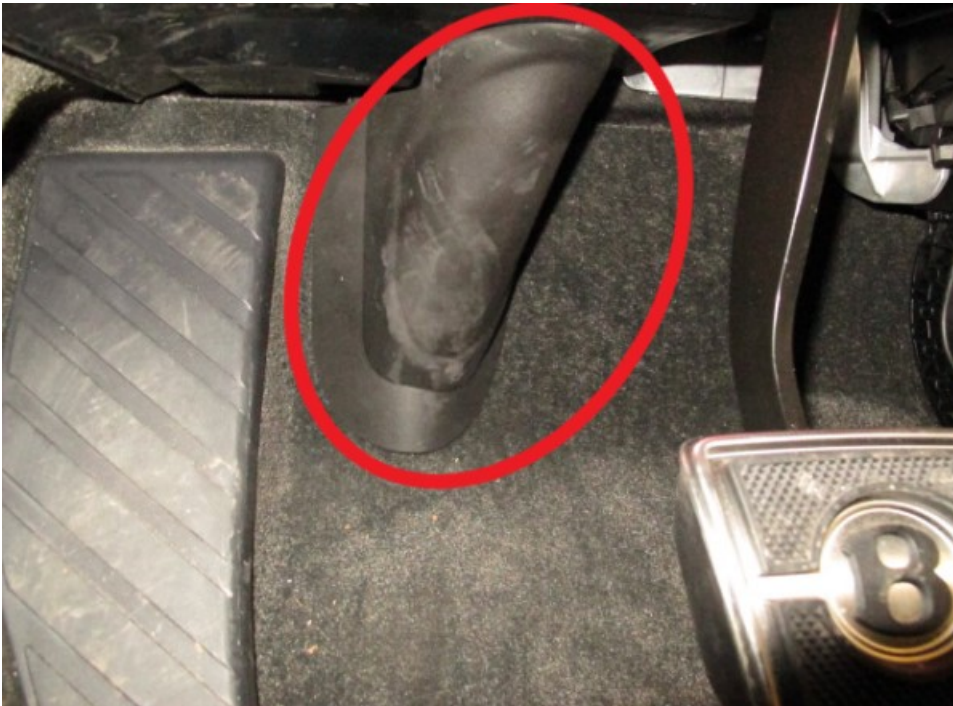
Figure 1

Squeaking noises from the foot well (Figure 1) with whilst steering / manoeuvring at low speed

- Noise is apparent with steering input whilst steering / manoeuvring at low speed
- Noise is evident from the rubber collar on the lower steering column
- Noise is apparent when the steering wheel is adjusted to the fully upwards position

- The rubber collar which is fitted to the intermediate steering shaft in some cases can contact the sealing boot
