# Technical Service Bulletin

<b>Topic</b>	Lower and/or upper front suspension lever brushes- Warranty replacement guidelines
<b>Market area</b>	Bentley: worldwide (2WBE),China 796 VW Import Comp. Ltd (Vico), Beijing (6796)
<b>Brand</b>	Bentley
<b>Transaction No.</b>	2075041/2
<b>Level</b>	EH
<b>Status</b>	Released for publishing
<b>Release date</b>	Feb 21, 2025

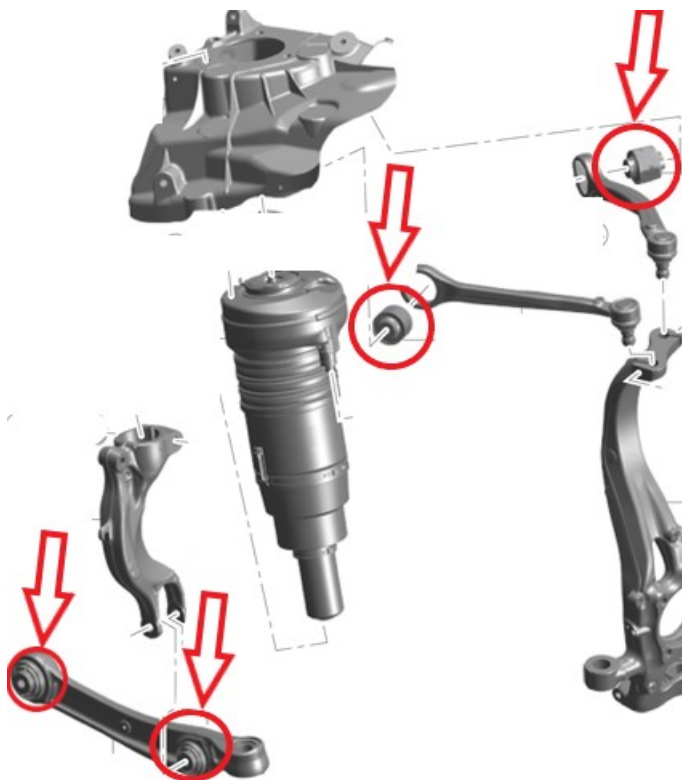
The left or right hand front lower and/or upper lever bushes (Figure 1) are exhibiting minor cracks (on inspection)

Before proceeding with replacing any of the lower and/or upper lever bushes shown in Figure 1 the operative must refer to the Technical background section of this TPI

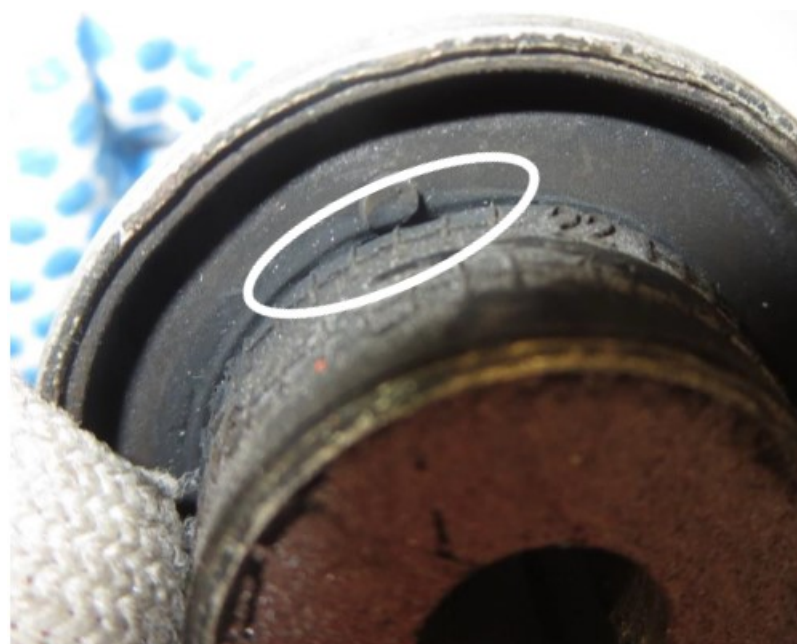
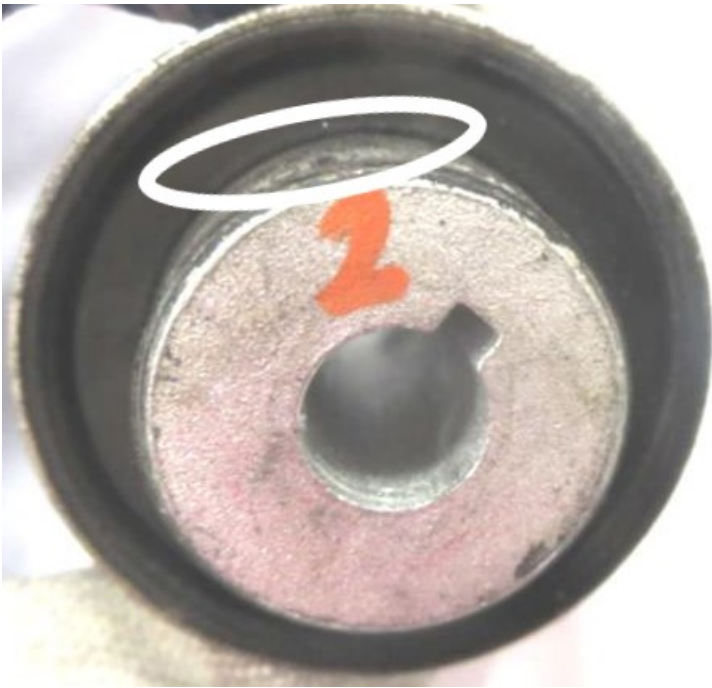
Should the bushes be in the condition shown in Figure 2 and 3 replacement is not required unless a customer complaint has been received relating to suspension noise - bush wear or overall serviceable condition
