# Technical Service Bulletin

<b>Topic</b>	Warnings within the DIP for the rear steering system - DTC B200096 and/or P060700 evident within diagnostic address 00CB
<b>Market area</b>	Australia E04 Bentley rest Asia and Australia (6E04),China 723 Volkswagen (Anhui) Automotive CO (6723),China 796 VW Import Comp. Ltd (Vico), Beijing (6796),Germany E02 Bentley rest Europe (6E02),Japan E03 Bentley Japan (6E03),Korea, (South) E08 Bentley South Korea (6E08),United Arab Emirates E06 Bentley Middle East and Africa (6E06),United Kingdom E01 Bentley UK (6E01),United States E05 Bentley USA and rest America (6E05)
<b>Brand</b>	Bentley
<b>Transaction No.</b>	2069252/3
<b>Level</b>	EH
<b>Status</b>	Released for publishing
<b>Release date</b>	Feb 24, 2025

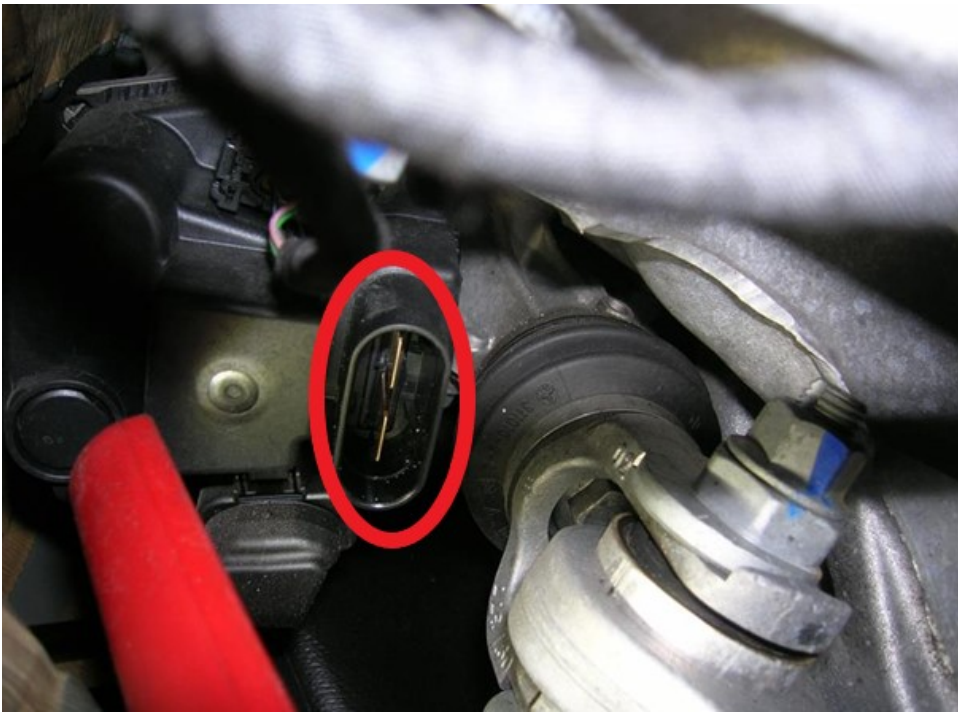
Figure 1

2) Referring to the applicable wiring diagram, conduct an electrical integrity check for the rear wheel steering control unit /J1019 (rear steering rack) in particular the 2-way 12V plug and connector (see the example shown in Figure 1) for any signs of corrosion or water damage

- Refer to the applicable wiring diagram - Check all applicable earth points of J1019 for Cleanliness, security and integrity - Rectify as applicable and retest to confirm if the DTC's are still evident
- If no faults were identified after conducting the wiring integrity checks the operative should confirm no faults were found and attach a current ODIS log to a new or existing DISS query
- The operative must await feedback from the new or existing DISS query before conducting any further work
