GENERAL MOTORS  
DCS7168  
URGENT - DISTRIBUTE IMMEDIATELY

Subject: N242468490 - Service Update  
Missing Chassis Harness Plugs

Models: 2024 – 2025 Chevrolet Blazer EV

## N242468490 Missing Chassis Harness Plugs

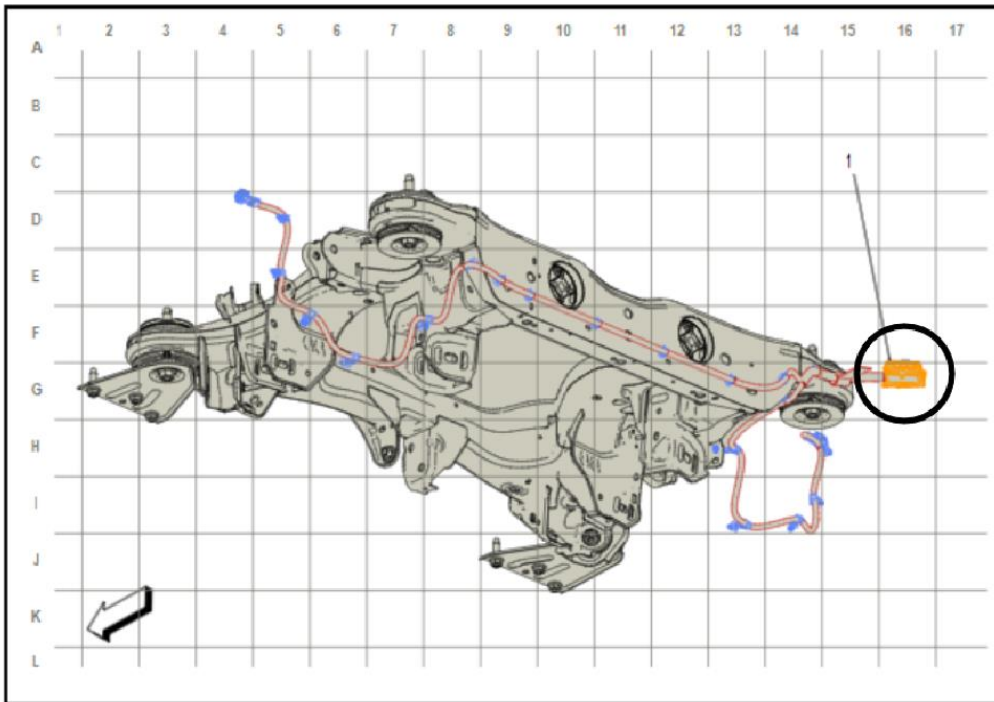
6778757

(1) X606 Body Wiring Harness to Chassis Wiring Harness

4. Locate and disconnect the X606 Body Wiring Harness to Chassis Harness Connector.
5. Verify there is no corrosion within the connector.

5.1 If corrosion is found in either connector, replace the corroded terminals and thoroughly clean the connector. Refer to *X606 Body Wiring Harness to Chassis Wiring Harness* in SI for terminal location and proper tools. Refer to *Wire and Connector Repair* in SI for further instruction.

5.2 If no corrosion is found: remove the plastic cover on the backside of the connector (if applicable) and proceed to the next step.

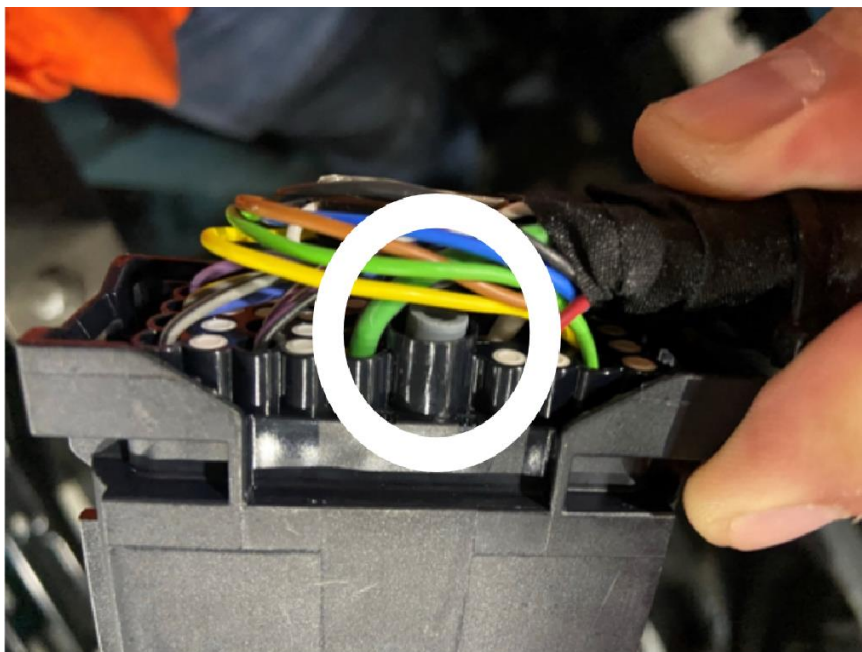
6779255

6. Inspect the large cavity plugs located within the X606 Body Wiring Harness to Chassis Harness Connector on the chassis harness.
  - 6.1 If the cavity plugs **PROTRUDE** from the connector body as shown in the above image, use a small round or flat bladed tool to press the cavity plug down into the cavity. Ensure the cavity plug is even on all sides and flush with the backside of the connector body.

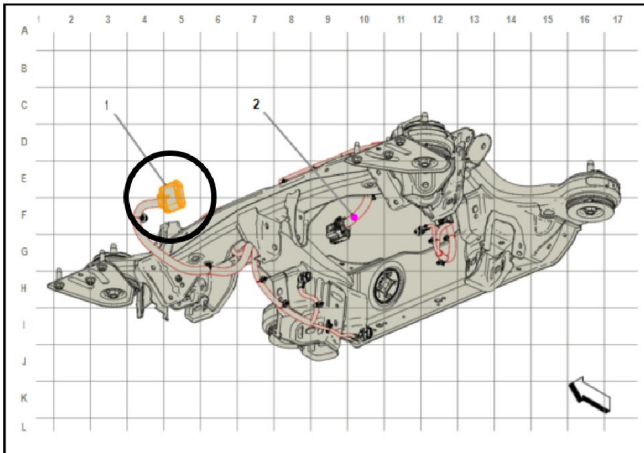
6780028

- (1) X610 Body Wiring Harness to Chassis Rear Wiring Harness (X0D / X0E)
- (2) J491 Chassis Rear Wiring Harness (X0D / X0E)

4. Locate and inspect X610 Body Wiring Harness to Chassis Rear Wiring Harness. Verify there is no corrosion within the connector.

4.1 If corrosion is found at either connector, replace the corroded terminals and thoroughly clean the connector. Refer to *X610 Body Wiring Harness to Chassis Wiring Harness* in SI for terminal location and proper tools. Refer to *Wire and Connector Repair* in SI for further instruction.

4.2 If no corrosion is found, clean and dry the connector and proceed to the next step.

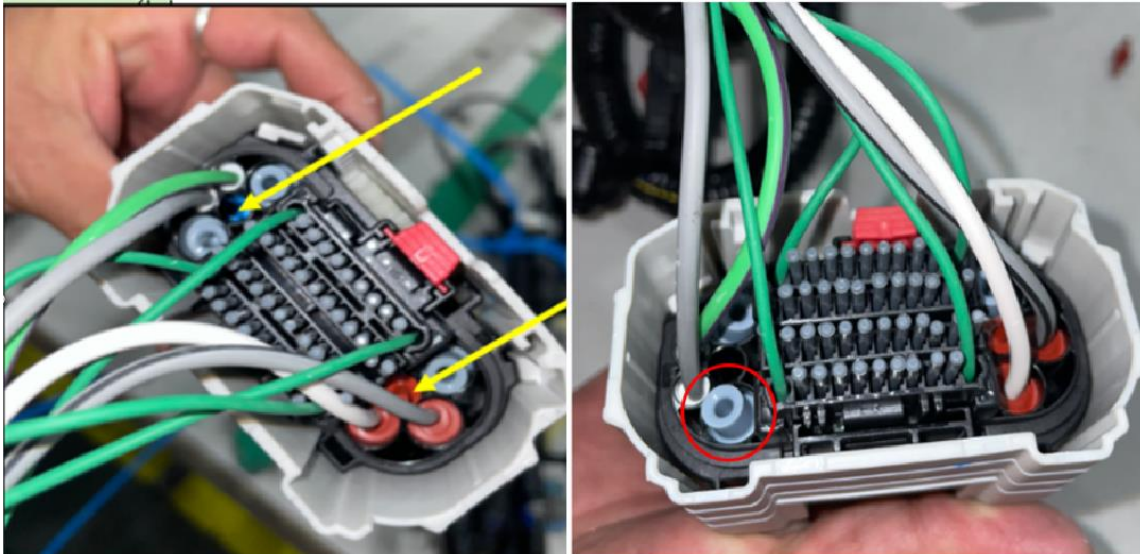
6781647

5. Inspect ALL blue and red cavity plugs to ensure they are seated flush and centered within the connector body.

5.1 If any of the cavity plugs **PROTRUDE** as indicated in the image above, use a small round or flat bladed tool to insert them correctly into the connector. Ensure the cavity plug seats flush and centered within the connector.
