# HYUNDAI

## Technical Service Bulletin

GROUP <b>HVAC</b>	NUMBER <b>25-HA-001H</b>
DATE <b>MARCH 2025</b>	MODEL(S) <b>ELANTRA (CN7, CN7A)</b>

**SUBJECT:** VENTILATOR LEVER INSPECTION & REPLACEMENT

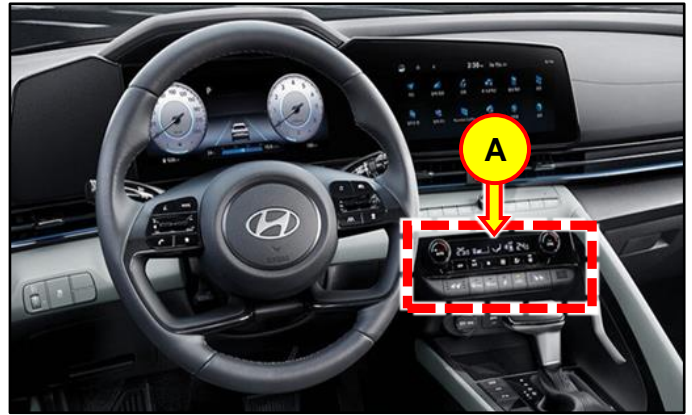
1. Turn **ON** the A/C or heater.
2. Set the airflow to **floor mode (A)** only.

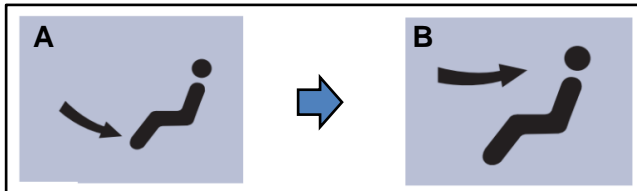
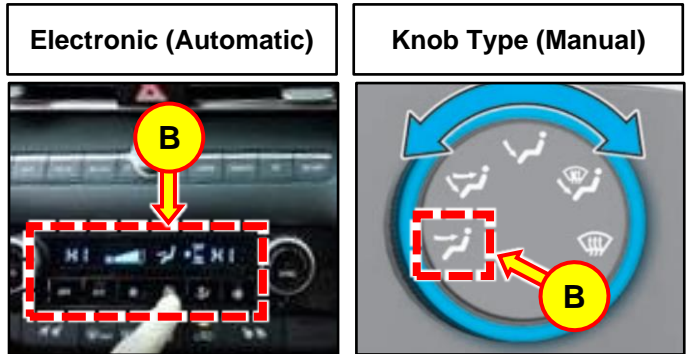
3. Change the mode actuator to the **forward-facing vent mode (B)** and verify if airflow is coming from the center vents.

- If there is airflow out of the center vents, but other concerns are present, this TSB does **NOT** apply. Diagnose and repair per the shop manual.
- If **NO** airflow is present from the forward-facing center vents, or a popping/snap noise is heard when switching modes, replace the ventilator lever.

Proceed to **Ventilator Lever Replacement**.

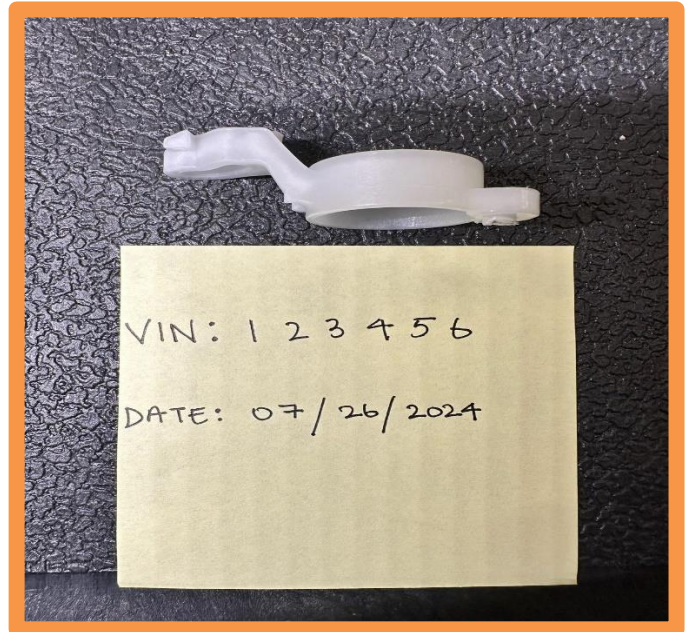
Using STUI, take a photo of the OLD ventilator lever arm with the last 6 digits of the VIN and the date of repair on a piece of paper.

Upload the photo to STUI.

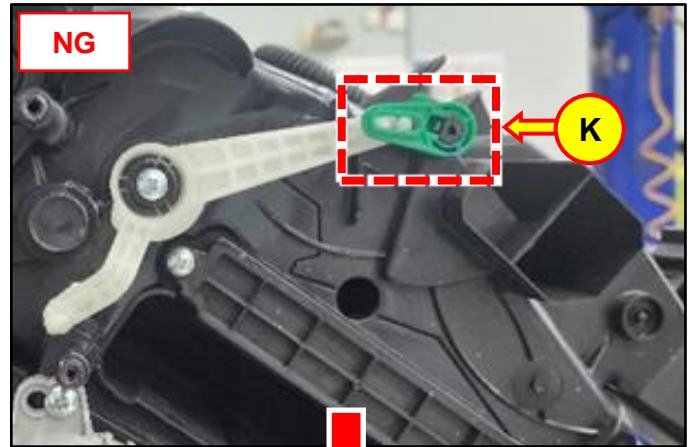
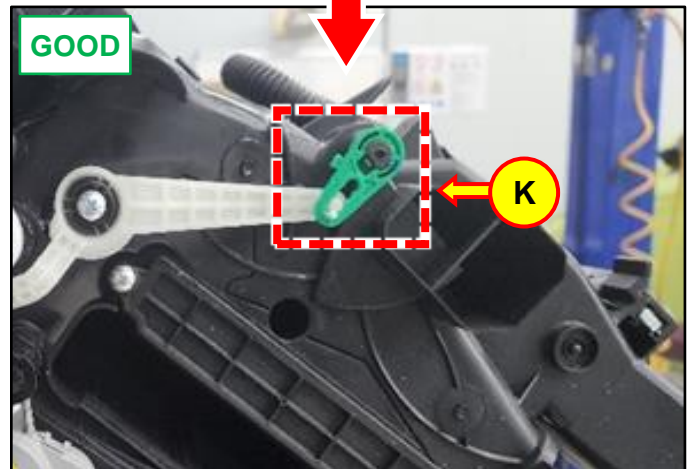
9. Before reinstalling the mode actuator and guide, inspect the position of the floor door lever (K).

If the floor door lever is horizontal as shown (**NG**), then correct the position by pushing the lever downward as shown in the second photo (**GOOD**).
